**ANNE ARUNDEL COUNTY
PUBLIC LIBRARY**

Library Facilities Assessment

August, 2023

Project L542406
WGM #202301.1

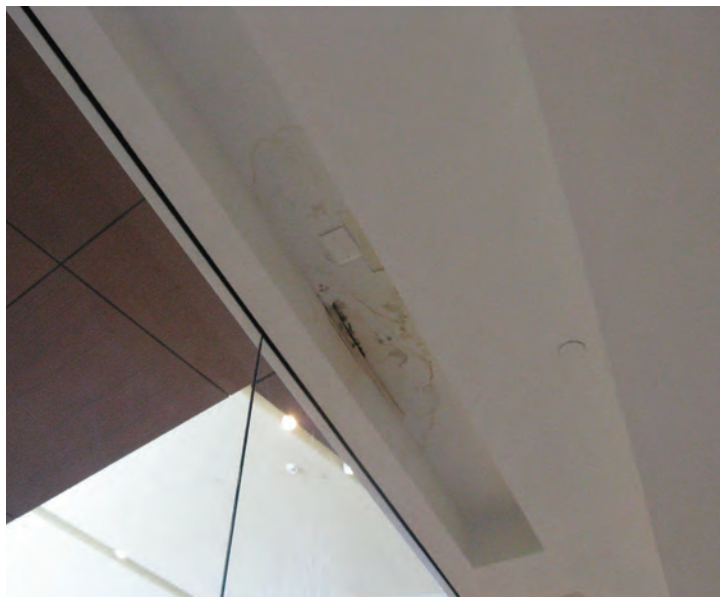
6.0		Wood								
AM-ANNAPOLIS MALL										
8.0		Openings								
AM-ANNAPOLIS MALL										
9.0		Finishes								
9.1		General								
9.2		GWB & Partitions								
	AM01	Address water stain and repaint GWB	AM01 (6)			\$425.00				
	AM01	Repair damaged GWB and repaint. Consider adding corner guards and select locations to minimize damaged due to library carts.	AM01 (7)			\$925.00				
	AM01	Repair damaged GWB caused by sliding the table along wall. Repaint.	AM01 (8)			\$250.00

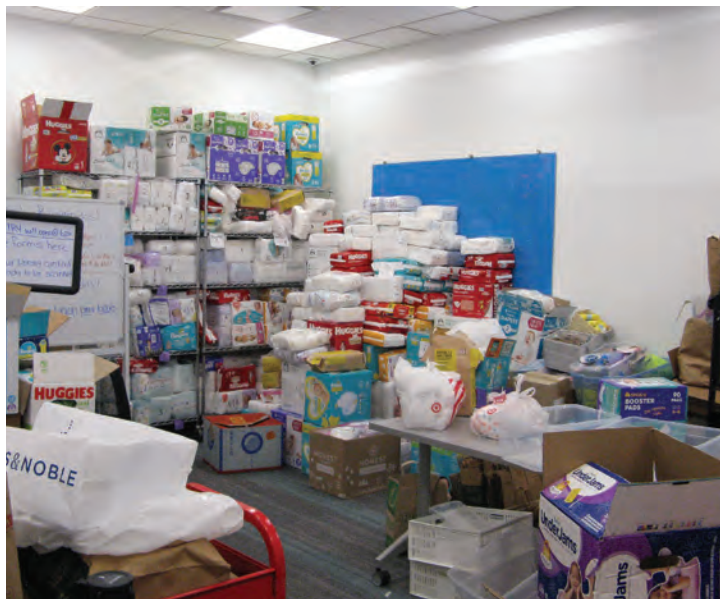
10.1		Signage								
	AM01	Relocate wall graphic "Community Pantry" if desired	AM01 (4)					\$1,250.00		
10.4		Lockers & Shelving								
	AM03	Recommend relocating the wire shelving from AM06 and install in AM03 for the Community Pantry use.	AM03 (1)				\$2,400.00			
AM-ANNAPOLIS MALL

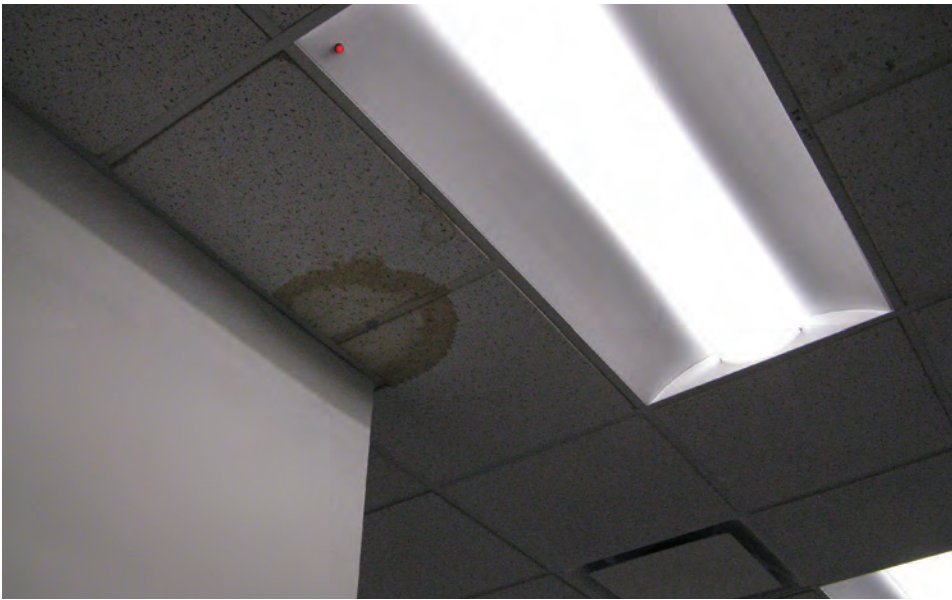
9.4		Ceilings								
	AM02	Replace stained 2 x 2 ACT	AM02 (3)			\$60.00				
	AM11	Replace stained 2 x 2 ACT	AM11 (4)			\$60.00				
	AM13	Replace stained 2 x 2 ACT	AM13 (2)			\$90.00

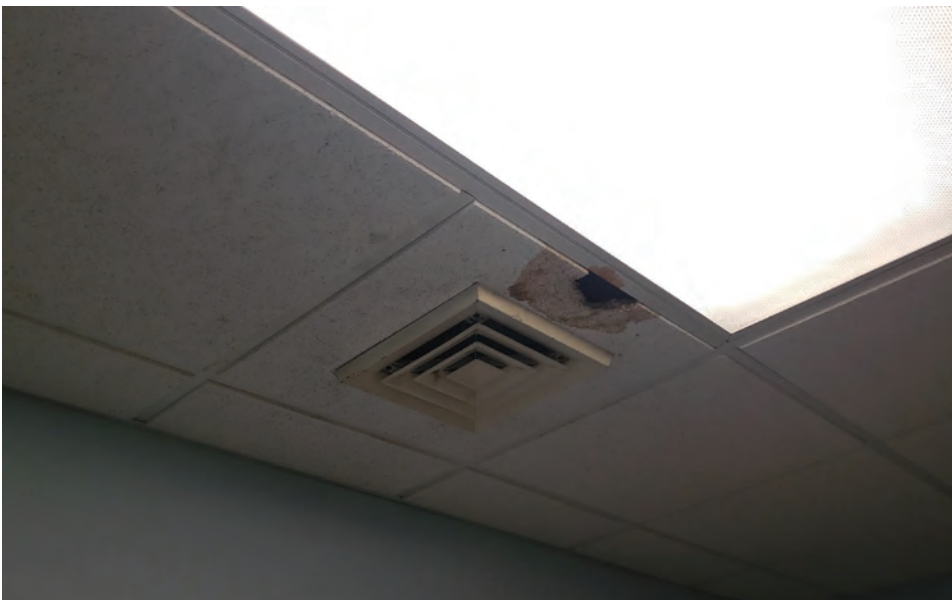
9.4		Ceilings								
	B07	Damaged ceiling tile to be replaced	B07 (1)		\$200.00					
	B13	Slatted ceiling may be acoustical or for air distribution. To be evaluated for removal.	B13 (2)						X	FMD to address this deficiency
	B20	Missing ceiling tiles	B20 (2)		\$200.00					
	B21	Restroom has ACT ceiling, consider replacement with GWB.							X

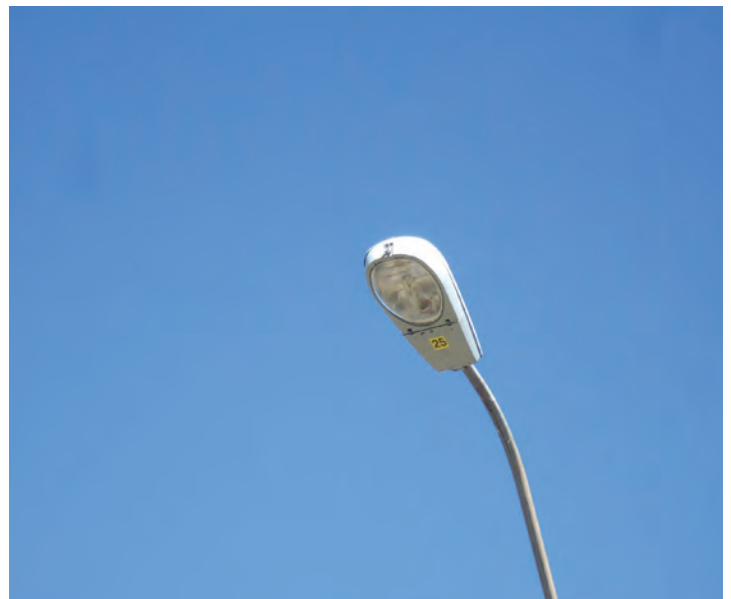
26.5		Site Lighting								
26.5.1		Relamp existing fixtures with LED lamps, or replace complete fixture with LED type.	B-EXT (E4)	5	\$800.00		\$4,000.00			Cost is to replace complete fixtures.
B-BROADNECK

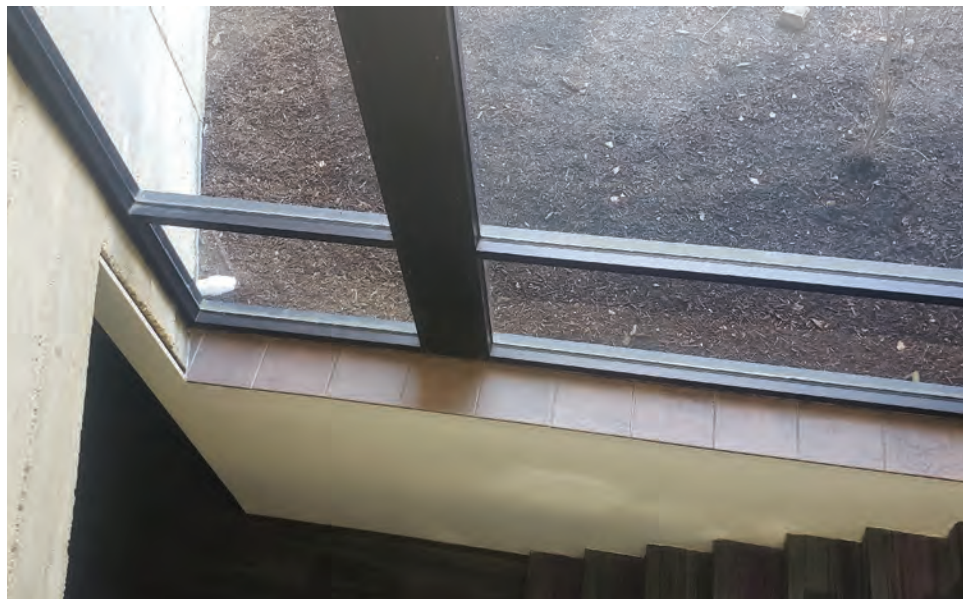
1.4		Safety								
1.4.1	BP21	Handrails at the split level entrance landing not compliant with ADA & Life Safety Codes. Modify or Replace existing to meet code. Add a new handrail along outside window wall	BP21 (1) BP21 (2)			\$7,500.00

5.0		Metals								
5.1		Framing								
5.2		Stairs & Railings								
5.2.1	BP21	Handrails at the split level entrance landing not compliant with ADA & Life Safety Codes. Modify or Replace existing to meet code. Add a new handrail along outside window wall	BP21 (1) BP21 (2)			SEE ABOVE				
BP-BROOKLYN PARK
