**ANNE ARUNDEL COUNTY
PUBLIC LIBRARY**

Library Facilities Assessment

August, 2023

Project L542406
WGM #202301.1

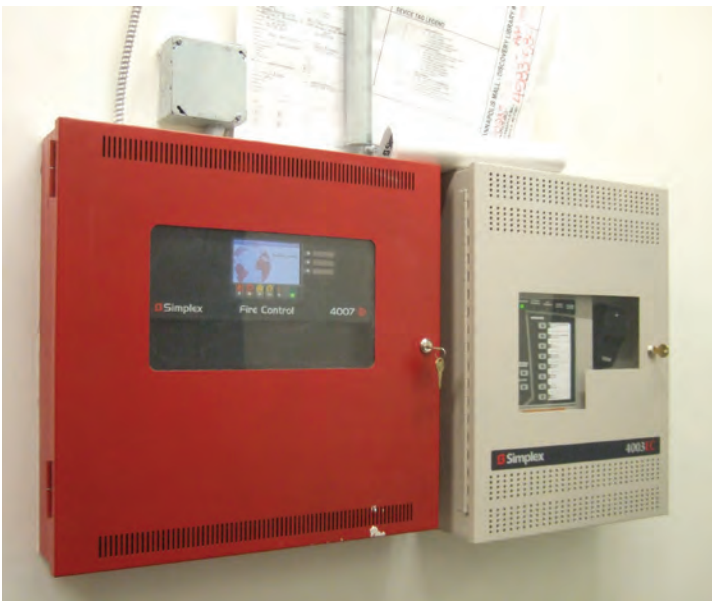
28.0		Electronic Safety								
28.1		Fire Alarm								
28.1.1		Fire alarm system for this space maintained by the library, and is tied into mall fire alarm system for annunciation.	AM04 (E1)							Background overview commentary
	AM06	Fire alarm strobe partially obstructed by shelving.	AM06 (E1)	1	\$400.00	\$400.00				
PRIORITY TOTALS						\$4,835.00	\$129,550.00	\$1,250.00	\$0.00

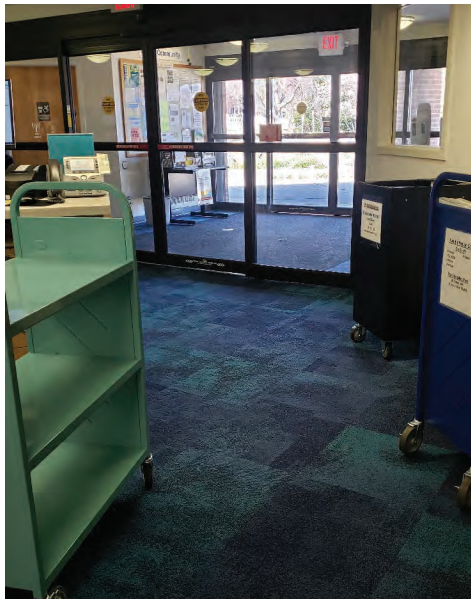
8.0		Openings								
8.1		Doors (interior)								
	B01	Interior vestibule doors should be evaluated for relocation.	B01 (2)						X	Consider as part of a larger renovation project
	B03	Door is not accessible and hardware is deteriorated	B03 (4)			\$2,800.00				
	B04	Door is not accessible and hardware is deteriorated	B04 (4)			\$2,800.00				
	B05	Hall entry door has been made accessible via motorized operator. Consider hall removal.	B05 (1)						X	Consider as part of a larger renovation project
	B08	Entry door has been made accessible via motorized operator. Consider relocation of entry via b17 holds	B08 (1)						X	Consider as part of a larger renovation project
	B21	Door is not accessible and hardware is deteriorated	B21 (3)			\$2,800.00

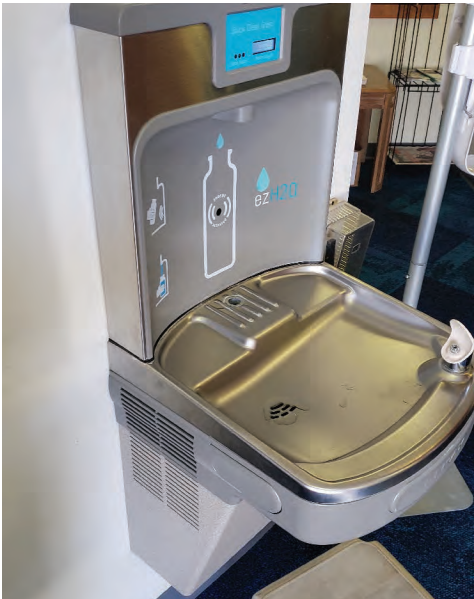
Item Ref.	Room	Description	Photo	Quantity	Unit Price	Priority 1	Priority 2	Priority 3	Priority 4	Comments
B-BROADNECK										
1.0		General								
1.1		Accessibility								
	B01	Provide high/low drinking fountains	B01 (4)			\$6,250.00				
	B02	Outside book drop access above 48" reach range.	B02 (1)			\$1,800.00				
	B03	Restroom is generally not accessible. Door swing does not provide required latch side clearance. Flush valve prevents required rear grab bar. Vertical grab bar not installed. Re-swinging door to swing out could fix door clearance issues.	B03 (1) B03 (2) B03 (3)			\$4,500.00				
	B04	Restroom is generally not accessible. Door swing does not provide required latch side clearance and overlaps lavatory fixture clearance. Flush valve prevents required rear grab bar. Vertical grab bar not installed. Urinal does not have fixture clearance and should be removed. Re-swinging door to swing out could fix door clearance issues.	B04 (1) B04 (2)			\$5,450.00

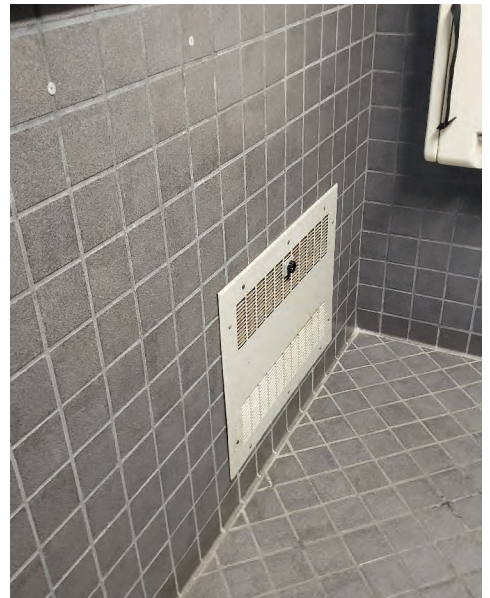
9.3		Tile								
	B03	Floor and wall tile is serviceable. Replacement may be required for restroom renovations.	B03 (5)					X		
	B04	Floor and wall tile is serviceable. Replacement may be required for restroom renovations.	B04 (1)					X		
	B21	Floor and wall tile is serviceable. Replacement may be required for restroom renovations.	B21 (4)					X

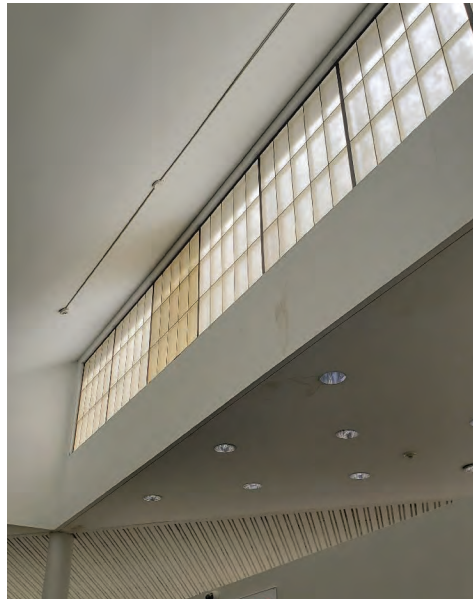
B25	Door hardware is of an older style and should be replaced to match newer hardware.				\$750.00				
8.4		Windows & glazing								
	B11	Discolored skylight panel	B11 (1)				\$4,000.00

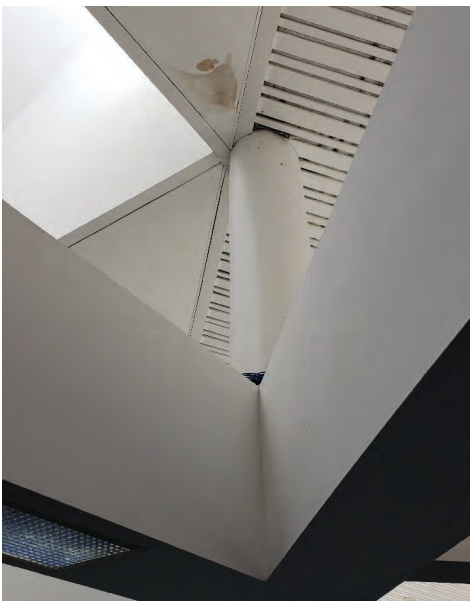
9.6		Paint								
	B11	Paint touchups required at water damage at skylights	B11 (3)		\$2,500.00					
B-BROADNECK										
10.0		Specialties								
10.2		Toilet compartments								
	B03	Toilet accessories are generally not accessible	B03 (6)						see above	
	B04	Toilet accessories are generally not accessible							see above	
	B21	Toilet accessories are generally not accessible							see above

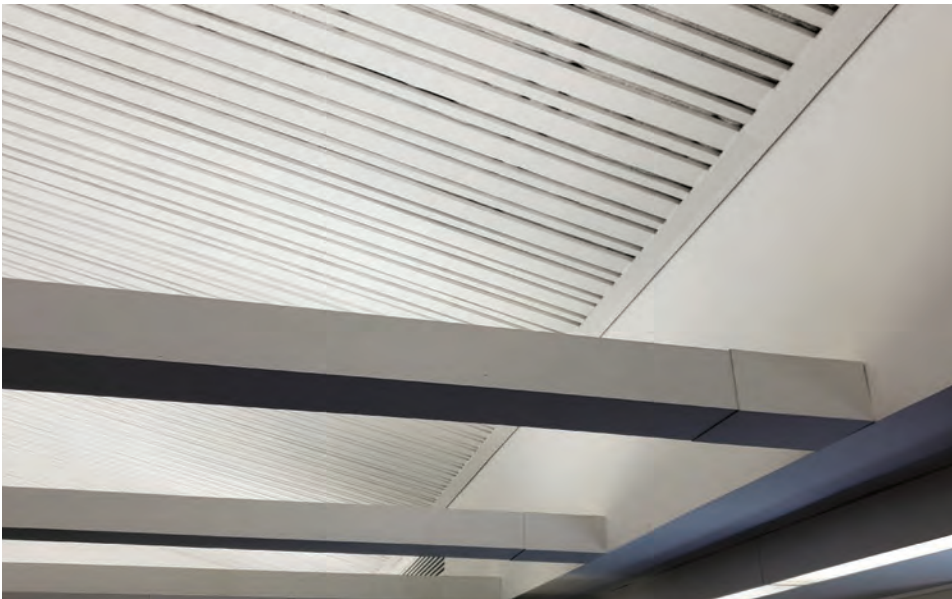
9.4		Ceilings								
	B07	Damaged ceiling tile to be replaced	B07 (1)		\$200.00					
	B13	Slatted ceiling may be acoustical or for air distribution. To be evaluated for removal.	B13 (2)						X	FMD to address this deficiency
	B20	Missing ceiling tiles	B20 (2)		\$200.00					
	B21	Restroom has ACT ceiling, consider replacement with GWB.							X

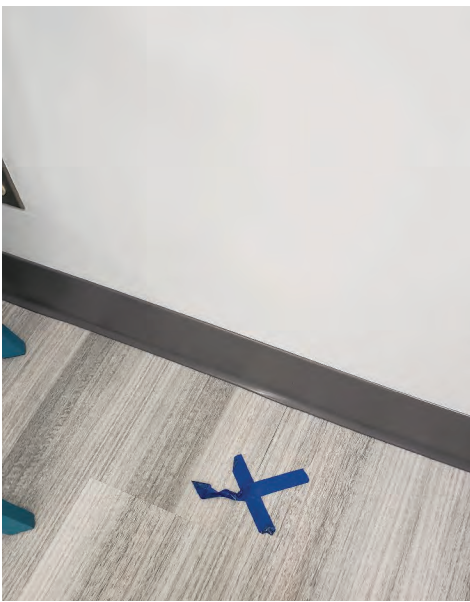
9.5		Flooring								
	B20	Laminate flooring appears damaged due to improper subfloor prep. Blue painters tape still in place on floor and wall base, possibly from unaddressed punchlist item.	B20 (3)		\$550.00

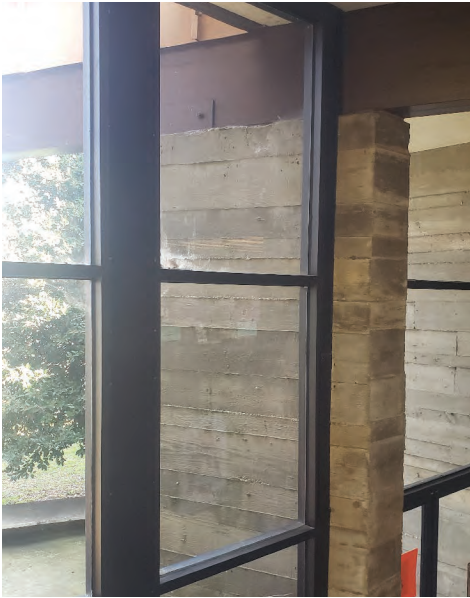
1.3		Limitations								
1.3.1	Gen.	The original library was constructed in 1971 of poured in place concrete walls and waffle slab concrete floors making it very difficult to make updated or changes to the building overtime. The windows form a large part of the façade and are single glazed units, offering little energy insulating benefit.								Background overview commentary
	BP02 BP03 BP05 BP05	The original windows form a large part of the façade and are single glazed units, offering little energy insulating benefit. The exterior envelope could be enhanced by a window replacement or adding interior storm windows to improve the heat loss of single glazing. Suggest Study to develop options for the exterior envelope improvements.	BP02 (1) BP03 (4) BP05 (1) BP05 (3)				\$568,500.00

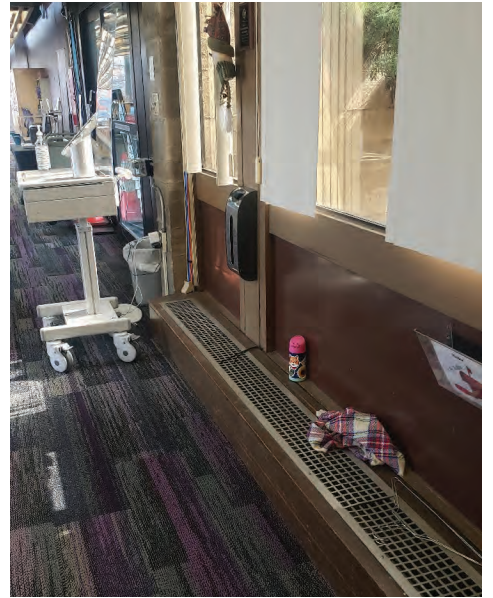
8.5		Window treatments								
	Gen.	Window treatments are either missing or in deteriorated state. Replace with modern roll-screen sunshades	BP02 (3) BP04 (1) BP13 (3)				\$49,500.00			
BP-BROOKLYN PARK

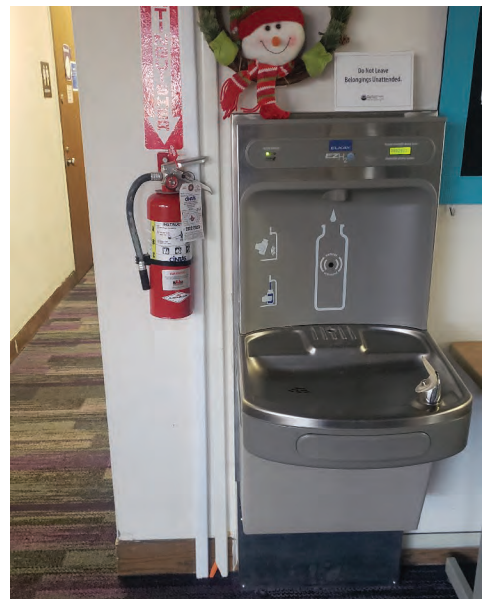
1.1		Accessibility								
	BP04	Single-height drinking fountain	BP04 (4)			\$6,250.00				
	BP09	Push/pull door may not be accessible with installed millwork	BP09 (3)				\$2,500.00			
	BP10	Missing vertical grab bar, mirror not located at lavatory	BP10 (2) BP10 (1)			\$300.00				
	BP11	Restroom not accessible	BP11 (2)			\$2,900.00				
	BP13	Kitchenette sink not accessible	BP13 (1)			\$5,000.00				
	BP14	Stove and refrigerator located in storage area and likely not accessible.	BP14 (1) BP14 (2)			\$500.00				Relocate refrigerator to BP 13
	BP15	Book drop operable parts above 48"				\$1,200.00				
	BP20	Landing is not accessible to either level				X				See 1.5.2 below
	BP25	Provide vertical grab bar and accessible toilet accessories	BP25 (1) BP25 (2)			\$200.00				
	BP26	Provide vertical grab bar and accessible toilet accessories	BP26 (1)			\$200.00				
	BP28	Lower level accessible entry via mechanical BP30

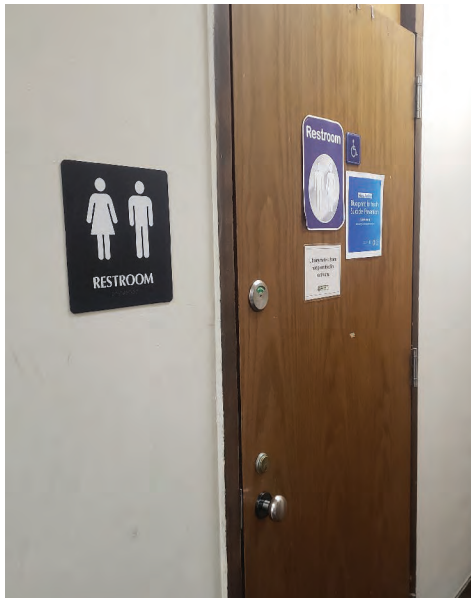
8.2		Door hardware								
	BP10	Non-lever hardware to be replaced	BP10 (3)			\$600.00				
	BP11	Cypher keypad access control hardware to be replaced	BP11 (2)			\$750.00				
	BP12	Non-lever hardware to be replaced	BP12 (5)			\$600.00

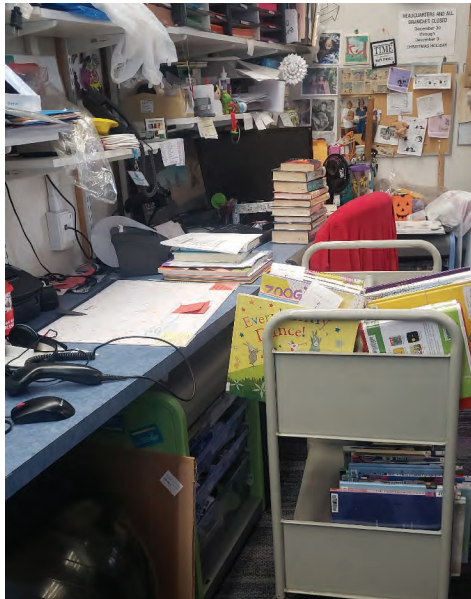
6.0		Wood								
6.1		Millwork								
	BP12	Remove built-in millwork and shelves, reconfigure workroom	BP12 (1) BP12 (3)				\$2,200.00			Demo cost, patch walls and paint only. Solution is FF&E
	BP13	Replace kitchenette with accessible millwork	BP13 (1)			SEE ABOVE				
BP-BROOKLYN PARK

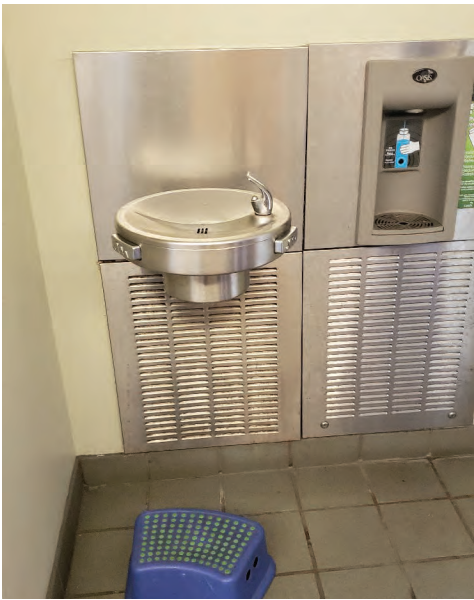
Item Ref.	Room	Description	Photo	Quantity	Unit Price	Priority 1	Priority 2	Priority 3	Priority 4	Comments
C-CROFTON										
1.0		General								
1.1		Accessibility								
	C01	Drinking fountain is not high/low, single height with separate bottle filler	C01 (1)			\$6,500.00				
	C02	Provide vertical grab bar in toilet compartment	C02 (1)			\$200.00				
	C03	Provide vertical grab bar in toilet compartment	C03 (1)			\$200.00				
	C13	Provide vertical grab bar in toilet compartment	C13 (1)			\$200.00				
	C23	Entry door does not have 18" required latch clearance at pull side. Existing door appears to remain held open at most times, re-swing or remove door. Countertop at 36" with no knee clearance at sink.	C23 (1)			\$4,500.00				
	C25	It appears that a parallel approach has been provided at the lavatory in lieu of a forward approach with knee clearance. Review fixture clearances and door overlap. Consider replacing lavatory with wall hung.	C25 (1)			\$650.00

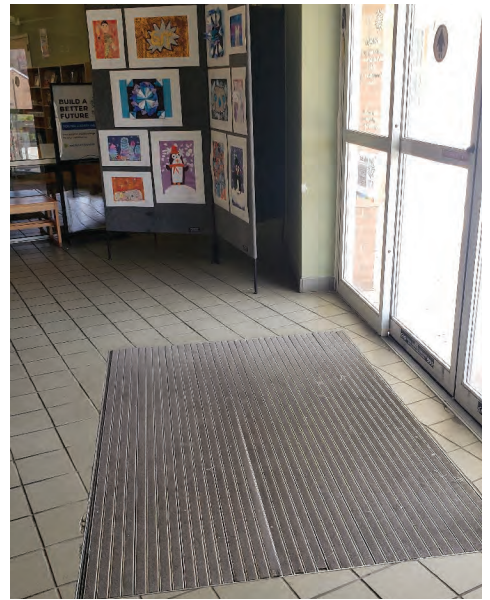
9.3		Tile								
	C01	Damaged quarry tile at walk-off mat. Remove and replace with larger walk-off carpet	C01 (3)				\$3,500.00			
9.4		Ceilings								
	C08	Repair damaged drywall bulkhead and ACT panels	C08 (2)			\$1,600.00				
	C15	Replace damaged ceiling tiles	C15 (1)			\$200.00				
	C20	Repair or reset damaged ceiling tiles at edges	C20 (1)			\$200.00

9.5		Flooring								
	Gen.	Replace carpet throughout					\$193.00			
	C01	Provide enlarged walk-off carpet	C01 (3)				\$2,000.00			
	C06	Replace carpet					\$1,200.00			
	C08	Replace carpet, consider portions to be LVT and portions to be carpet for ease of program cleanup and for child comfort sitting on floors					\$10,000.00			
	C10	Replace carpet					\$3,900.00			
	C11	Replace carpet					\$58,000.00			
	C12	Replace carpet					\$13,100.00			
	C14	Replace carpet					\$6,100.00			
	C15	Replace carpet					\$2,700.00			
	C16	Replace carpet					\$13,100.00			
	C17	Replace carpet					\$18,900.00			
	C18	Replace carpet at removed desk					\$4,100.00			
	C19	Replace carpet					\$19,000.00			
	C20	Replace carpet, coordinate with revised furniture/desks if provided					\$27,000.00			
	C21	Replace carpet					\$1,500.00			
	C22	Replace carpet					\$2,150.00			
	C23	Replace carpet					\$5,400.00

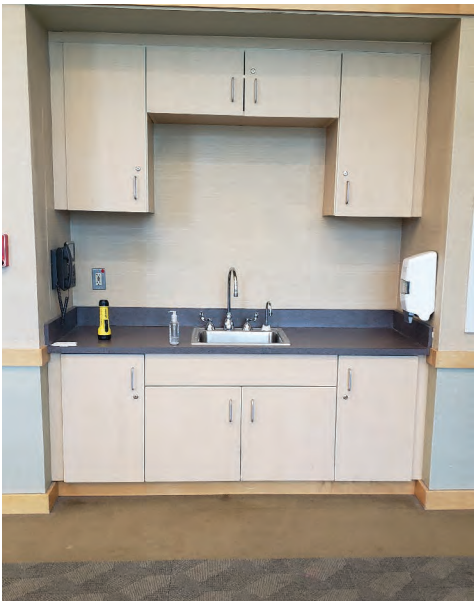
6.0		Wood								
6.1		Millwork								
	C08	Remove left kitchenette and enlarge C07 storage area with access from C08	C08 (1)					\$2,200.00		
	C23	Counter at 36" with no knee clearance, remove and replace or modify existing millwork.				\$2,000.00

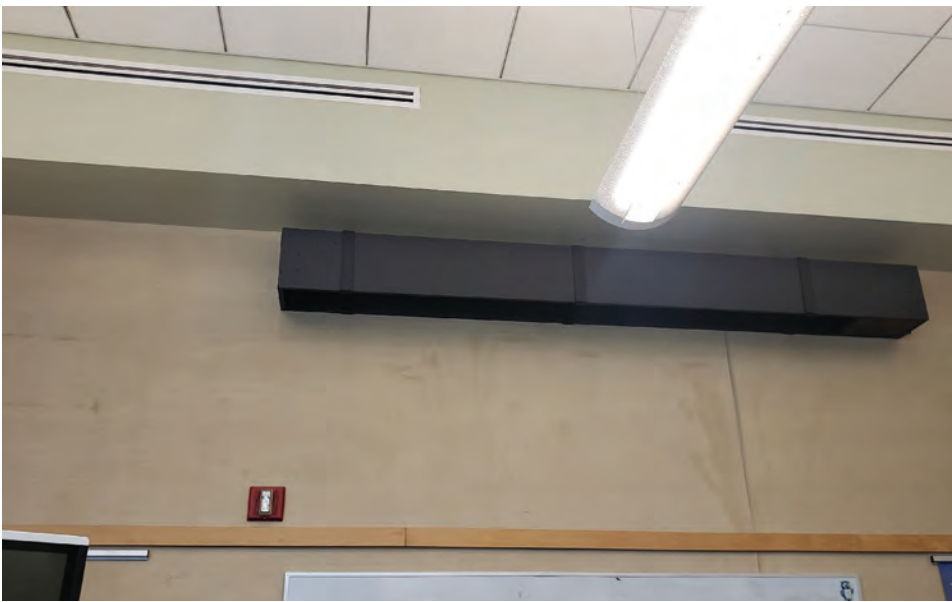
9.0		Finishes								
9.2		GWB & partitions								
	C08	Repair damaged drywall, remove wallpaper and paint walls.	C08 (5)			\$13,000.00				
	C29	Repair damaged drywall and repaint at rear of room	C29 (2)			\$900.00

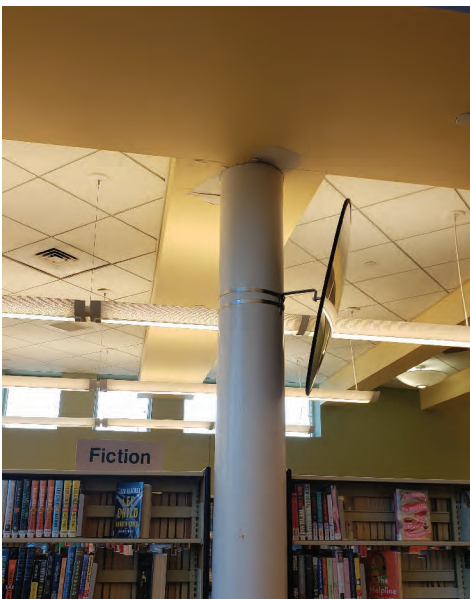
9.6		Paint								
	C16	Repaint bulkhead near column	C16 (1)			\$500.00				
	C19	Repair and repaint at water damage adjacent to quiet room.	C19 (1)			\$1,500.00				
	C20	Repair and repaint at column	C20 (2)			\$750.00				
	C29	Repair damaged drywall and repaint at rear of room	C29 (1)			\$900.00				
C-CROFTON

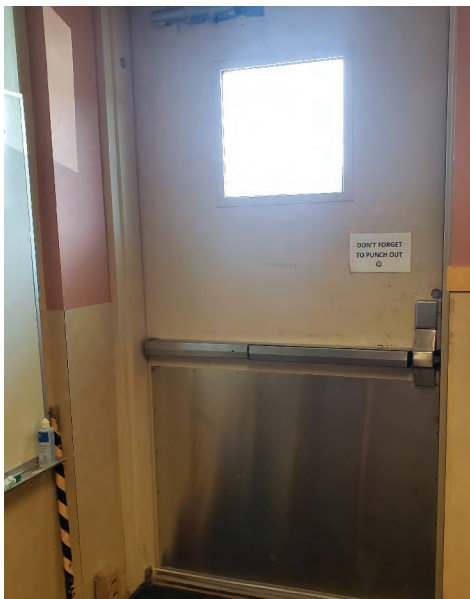
Item Ref.	Room	Description	Photo	Quantity	Unit Price	Priority 1	Priority 2	Priority 3	Priority 4	Comments
C-CROFTON										
8.0		Openings								
8.1		Doors (interior)								
	C28	Electrical room door to swing in the direction of egress travel, remove and replace.	C28 (1)			\$2,600.00				
	C32	Staff requested peep hole in exterior door as the existing lite is well above typical eye level	C32 (1)			\$150.00

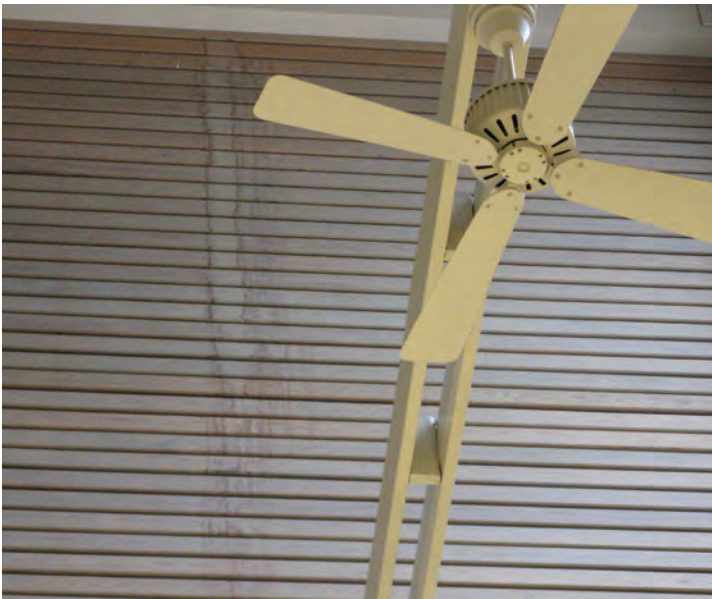
9.6		Paint								
	D05	Water staining on the interior of the upper clerestory should be cleaned and repainted. Also if the staining is recent, the metal cladding on the roof should be inspected.	D05 (3)			\$14,000.00				
D-DEALE

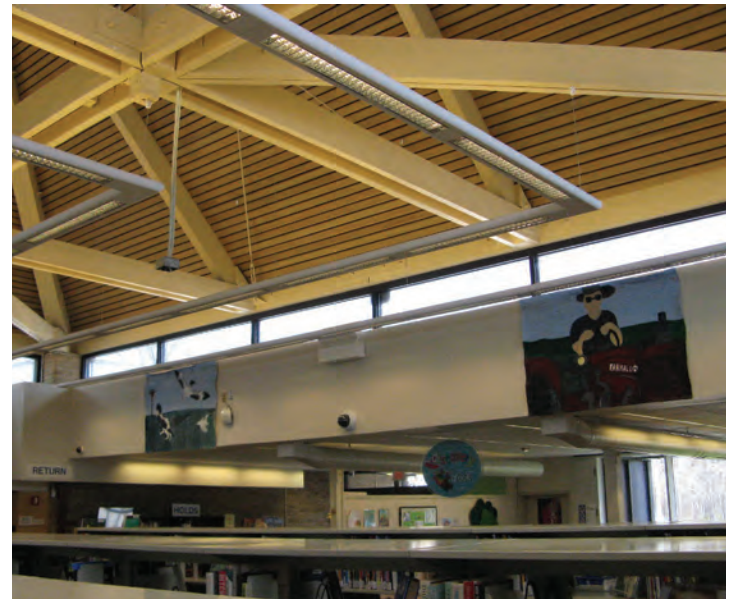
5.0		Metals								
D-DEALE										
6.0		Wood								
D-DEALE										
8.0		Openings								
8.4		Windows & Glazing								
	D05	The high bay area clerestory glazing creates glare on computer screens. Recommend placing interior UV shading film to reduce the glare.	D05 (4)				\$7,400.00

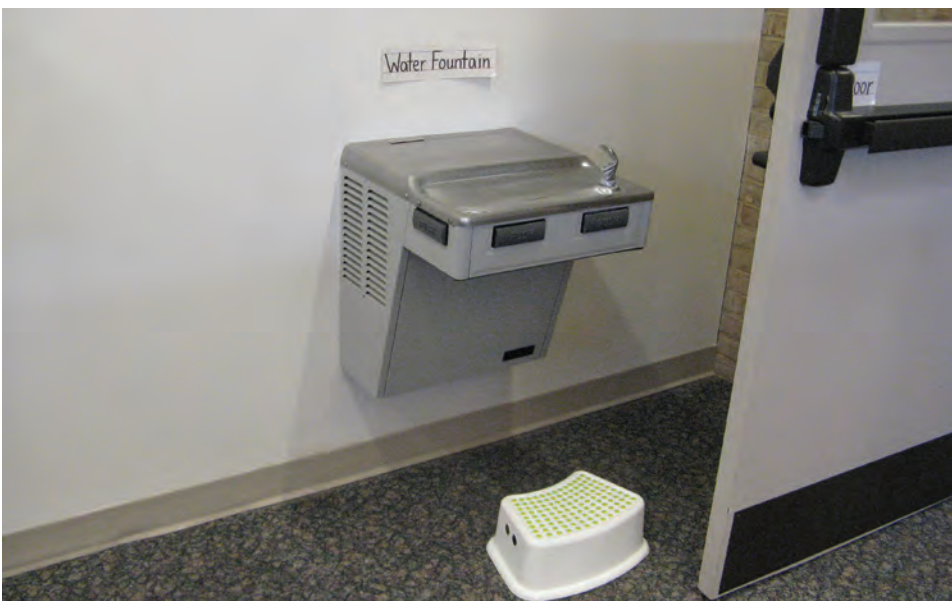
Item Ref.	Room	Description	Photo	Quantity	Unit Price	Priority 1	Priority 2	Priority 3	Priority 4	Comments
D-DEALE										
1.0		General								
1.1		Accessibility								
	D05	Provide a high/low EWC with bottle-filler station	D05 (5)			\$6,500.00				
	D07	Single User Restroom update grab bar for ADA Access	D07 (1)			\$200.00				
	D08	Single User Restroom update grab bar for ADA Access				\$200.00				
	D13	Modify Meeting Room Kitchenette for ADA Access	D13 (1)			\$6,600.00				
	D21	Single User Restroom update grab bar, install ADA mirror above sink and remove free standing storage unit to provide necessary clearances	D21 (1)			\$900.00				
	D29	Modify Staff Lounge base cabinets for ADA Access	D29 (1)			\$8,100.00

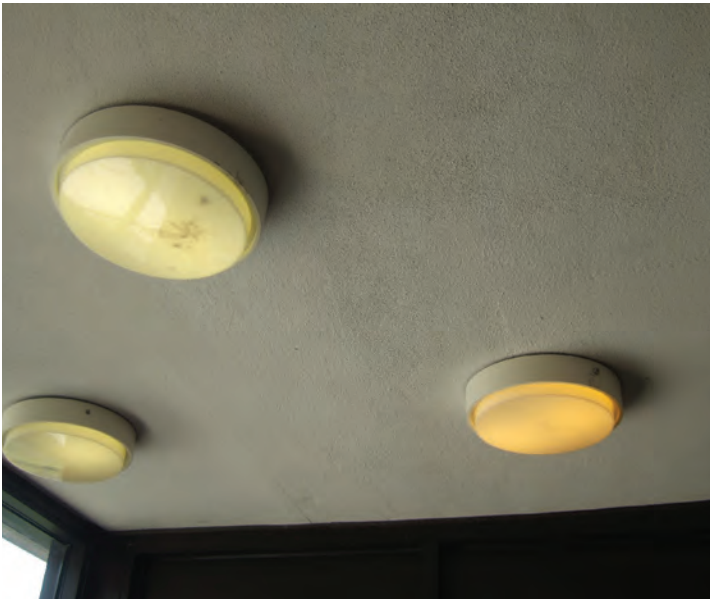
26.4		Lighting								
26.4.1	Gen.	Replace fluorescent lighting throughout with energy efficient LED.		1	LS		\$52,000.00			
	Gen.	No automatic lighting controls.								Background overview commentary
	D01	Lens of ceiling lights are yellowing - replace with new LED fixtures.	D01 (E1)				X			Included in lighting retrofit cost given above.
	D20	Exit sign appears to be unlit (or underlit). Panel 'C' is in poor condition and not securely mounted.	D20 (E1) D20 (E2)	1	LS	\$2,200.00				Cost to replace exit sign and Panel 'C'.
D-DEALE

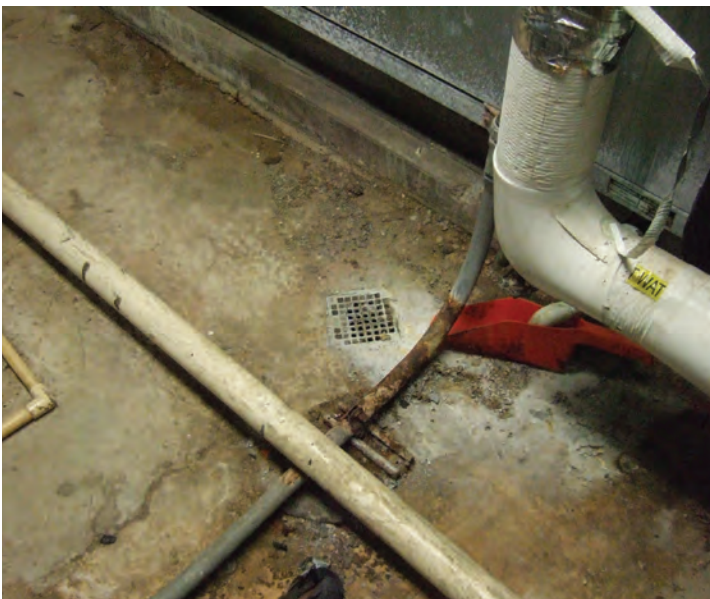
22.2		Piping								
22.2.1	D25	Corroded conduit (for controls) in Mechanical Room	D25 (P1)	1	LS	\$5,000.00				
D-DEALE										
26.0		Electrical

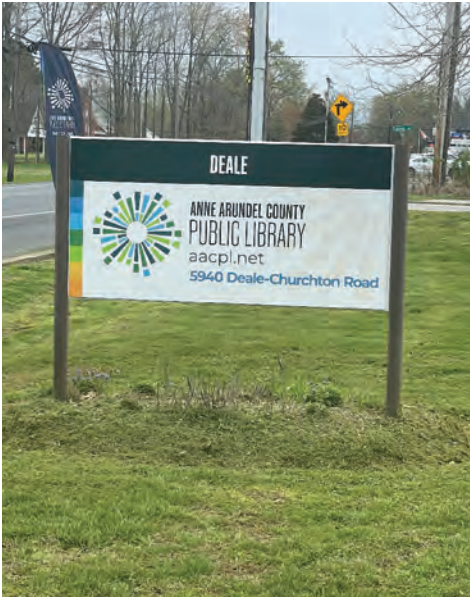
DS (1)

2.3		Accessories & Signage								
2.3.2		Standard library signage present at entry drive	ES (1)					X		
2.4		Sidewalks								
2.4.1		Sidewalk appears to be in good condition. Good connectivity of sidewalks with the surrounding community						X

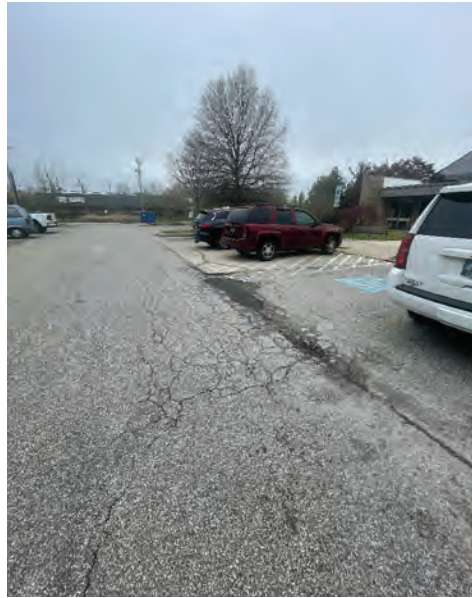
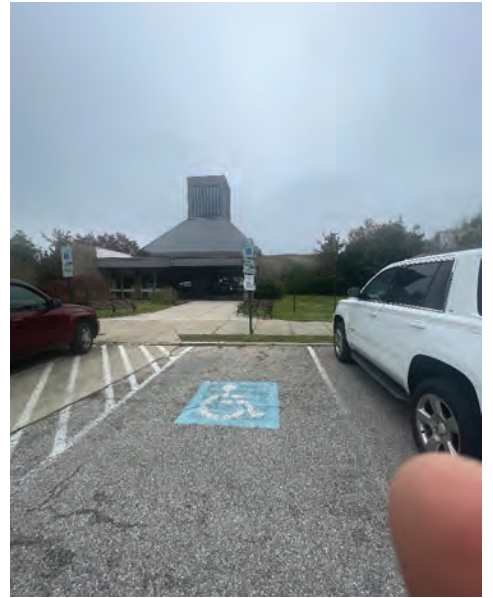
DS (2)

2.5		ADA signage, parking spaces and accessibility								
2.5.1		One of the 4 ADA spaces at the front entry marked in the parking lot is incorrectly designated a van space, however, it does not meet the ADA minimum dimensions to be considered van accessible Recommend that the curbing be widened to provide ADA compliant van accessible space	ES (2) ES (3)	1	\$3,195.00	\$3,195.00

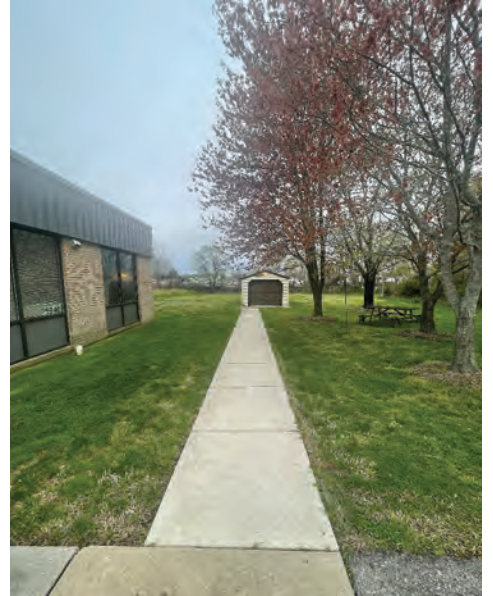
DS (6)

2.5.4		The rear ADA spaces have slopes that exceed the 2% limitation. Additionally, similar to the front ADA spaces, no ramps are provided to the walkways and recommend installation of ADA compliance ramps and access to the building entries.	ES (6)				X			SEE 2.2.1 ABOVE

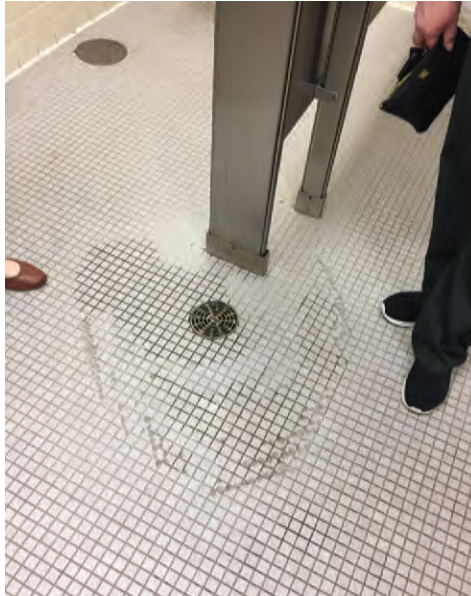
9.3		Tile								
	E05	Repair tile to gain positive floor slope to floor drain	E05 (2)			\$3,900.00				
	E22	Repair tile to gain positive floor slope to floor drain	E22 (1)			\$2,000.00				
	E23	Repair tile to gain positive floor slope to floor drain	E23 (1)			\$2,000.00

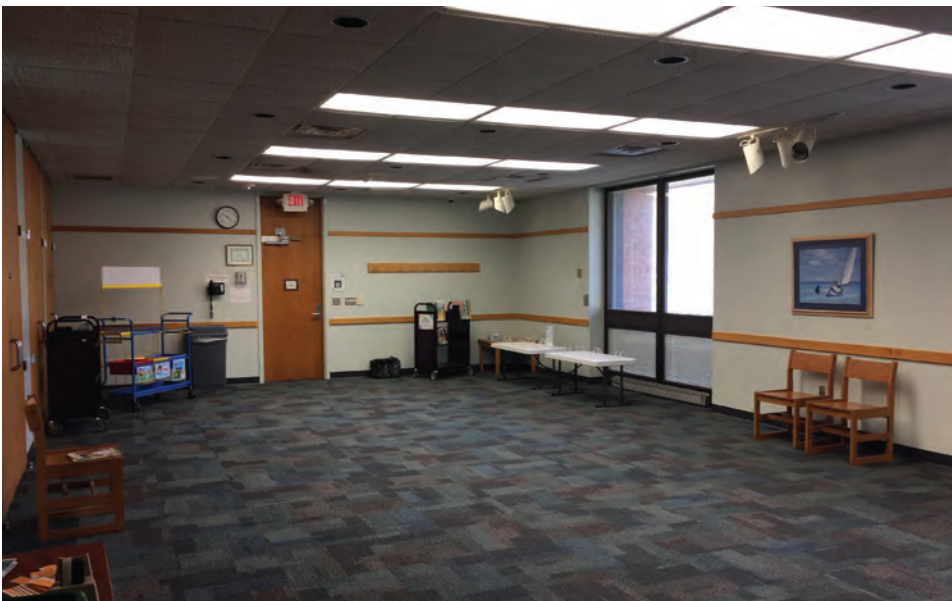
1.2		Function								
1.2.1	E07	Modify common wall with E11 Space to provide new dividing partition and two new entrances into meeting room(s). Replace storage closets lost to new entrances/partition	E07 (1) E11 (4)					\$165,000.00		Architectural improvements only. Does not include ffe.
	E11	Demolish existing canopy to create new floor plan options for community seating, tech stations etc.	E11 (1) E11 (2)					\$65,000.00		Architectural improvements only. Does not include ffe.
	E11	Acoustics: Provide additional sound panels along lower octagonal vertical face of open library space	E11 (1)				\$15,000.00

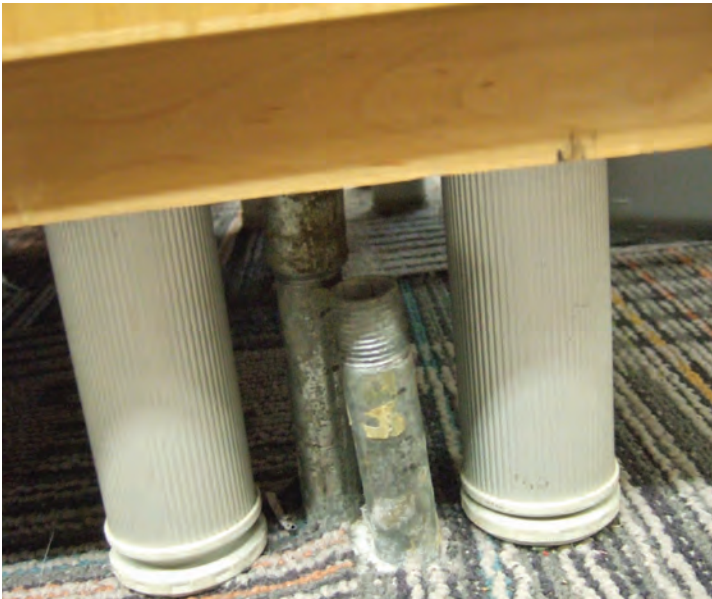
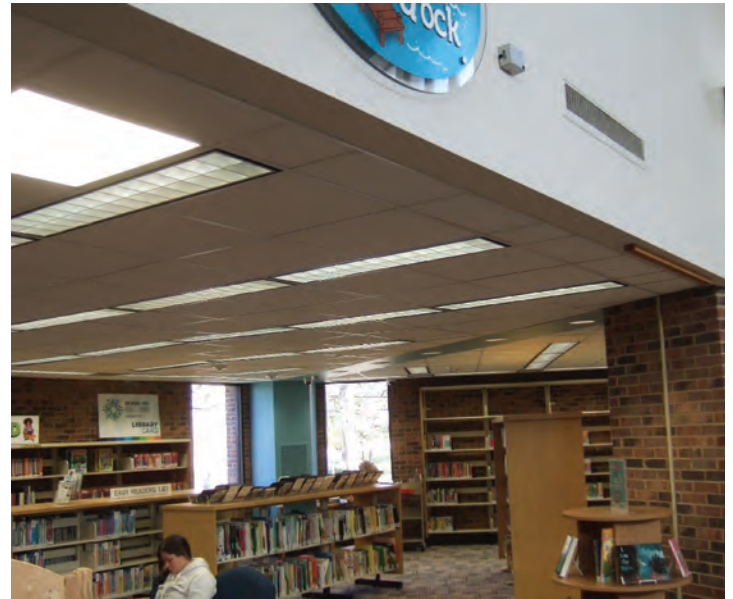
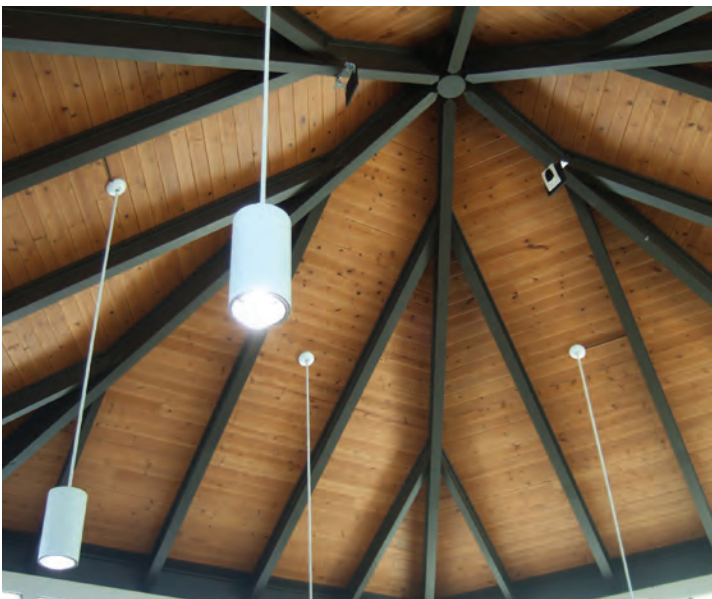
26.4		Lighting								
	Gen.	General - Replace fluorescent lighting throughout with energy efficient LED.		1	LS		\$80,000.00			
	Gen.	General - no automatic lighting controls except in restrooms.								Background overview commentary
	EA06	Complaint that this area is too dim. Wall lights have been retrofit with LED lamps w/ active cooling (fans), which is noisy. Recommend replacement with brighter LED wall lights without active cooling.	EA06 (E1)				X			Included in lighting retrofit cost given above.
	EA13	Clerestory - complaint that this area is too dark at night. Pendant and wall lights have been retrofit with LED fixtures with active cooling (fans), which is noisy. Recommend replacement with brighter LED pendants/wall fixtures without active cooling. Stack areas - existing fluorescent lights have parabolic diffusers, recommend replacement with LED w/ lens.	EA13 (E1) EA13 (E2) EA13 (E3)				X			Included in lighting retrofit cost given above.

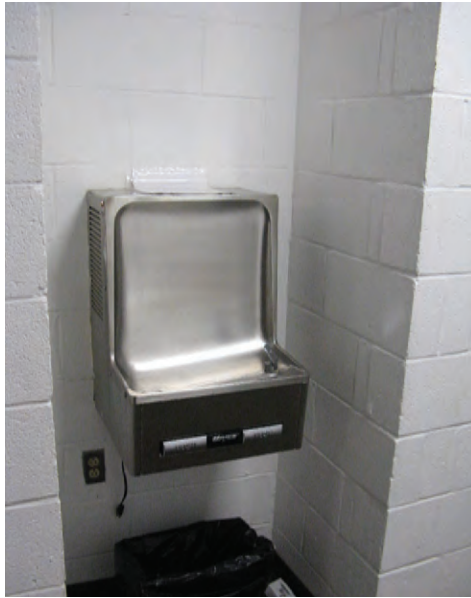
H107 (1)

26.3		Wiring Devices								
	H106	Receptacle adjacent to mop sink does not appear to be GFCI protected.	H106 (E1)	1	\$75.00	\$75.00				
	H107	Receptacle adjacent to EWC does not appear to be GFCI protected.	H106 (E1)	1	\$75.00	\$75.00				
	H101	480 volt panel in room is unlabeled, and missing directory.	H101 (E1)	1	\$350.00			\$350.00		
	H125	Remove unused fan switch. Receptacle above sink does not appear to be GFCI protected.	H125 (E1)	1	LS \$350.00	\$350.00				
	H127	Two receptacles above counter and within 6' of sink do not appear to be GFCI protected.	H127 (E1)	2	\$150.00	\$300.00				
	H222	Receptacle above vending machine not securely mounted.	H222 (E1)	1	\$75.00		\$75.00			Cost to re-secure.
	H223	Two receptacles above counter and within 6' of sink do not appear to be GFCI protected.	H223 (E1) H223 (E2)	2	\$150.00	\$300.00				
	H226	Receptacle adjacent to sink does not appear to be GFCI protected.	H226 (E1)	1	\$150.00	\$150.00

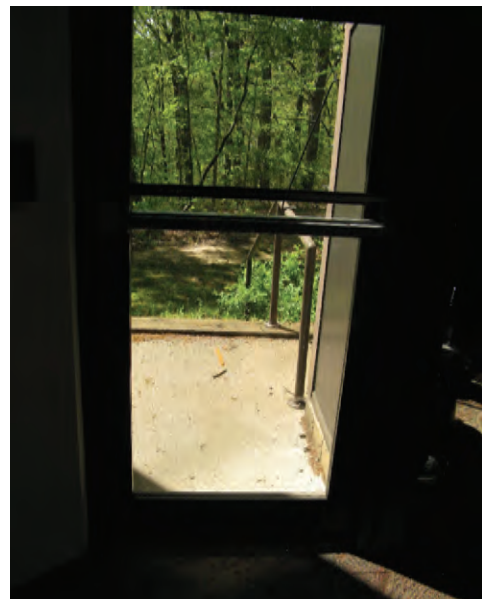
1.4		Safety								
1.4.1	Gen.	Only the lower level has fire suppression system installed. The monumental open communicating staircase between floors has non compliant handrails and guardrails. The carpet treads & risers present a hazard. The upper level remote exits are exterior covered stairs.								Background overview commentary
	H209A	Exterior exit stair, modify to provide guardrail protection and prior handrail extensions.				\$7,400.00				
	H214	Monumental open communicating staircase does not have code compliant handrails or guardrails. The staircase railings should be modified or replaced. Carpeted treads/risers should be replaced with rubber non slip treads, etc.	H214 (1)			SEE ABOVE				
	H240A	Exterior exit stair, modify to provide guardrail protection and prior handrail extensions.	H240A (1)			\$7,400.00				
	Site	The lower level occupancies have three (3) emergency exits that discharge directly onto the surrounding exterior grades. The conditions outside the existing doors do not meet current code. Repair exterior exit landings and provide a safe route away from the building.	H109 (3) H128 (1)			\$3,500.00

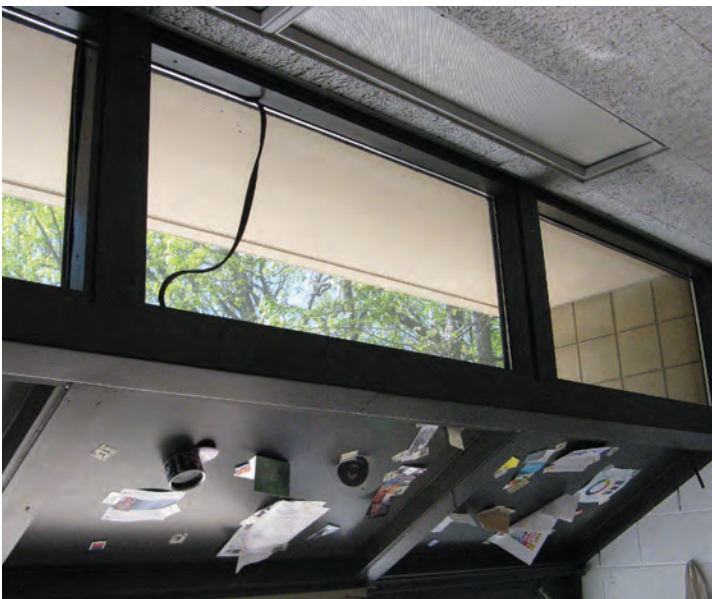
5.0		Metals								
H-HEADQUARTERS										
6.0		Wood								
H-HEADQUARTERS										
8.0		Openings								
8.4	Gen.	Many windows have evidence of failing weatherstripping/gaskets. Inspect all windows and replace weatherstripping/gaskets as needed.	H204 (2) H205 (1) H208 (1) H227 (2)			\$5,000.00				Allowance

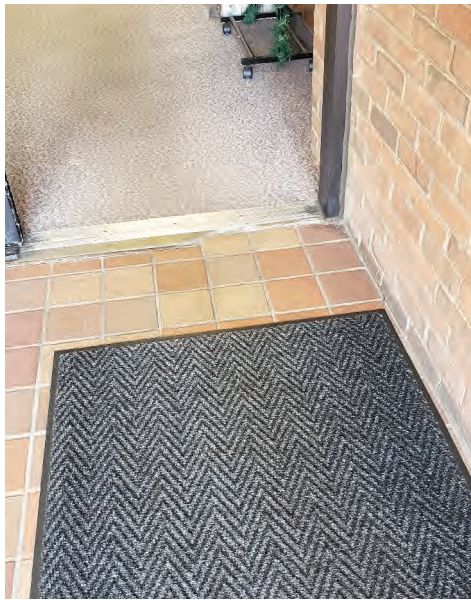
Item Ref.	Room	Description	Photo	Quantity	Unit Price	Priority 1	Priority 2	Priority 3	Priority 4	Comments
L-LINTHICUM										
1.0		General								
1.1		Accessibility								
	L01	Entry threshold not ADA compliant, large vertical transition.	L01 (2)			\$300.00				
	L02	Kitchenette not compliant	L02 (4)			X				
	L04	Restroom is not accessible.	L04 (1) L04 (2) L04 (3)			X				
	L05	Restroom is not accessible.	L05 (1) L05 (2) L05 (3) L05 (4) L05 (5)			X				
	L08	Stair is the only internal access for basement and limits staff access	L08 (1)						X	Background overview commentary
	L09	Drinking fountain is single height and lacks fixture clearance.	L09 (1)			\$6,500.00				
	L21	Kitchenette is not accessible.	L21 (1)			\$6,800.00				
	L22	Restroom is not accessible.	L22 (1)			X				
	L25	Basement level is not accessible	L25 (1)						X	Background overview commentary
	L27	Basement level is not accessible	L27 (1)						X	Background overview commentary

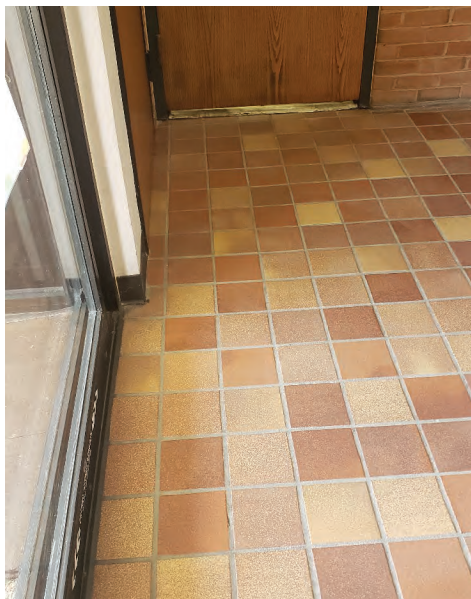
9.5		Flooring								
	L01	Quarry tile is in serviceable condition, consider replacement with walk-off flooring.	L01 (8)					\$4,800.00		
	Gen.	Replace carpet & vinyl flooring throughout per scheduled renewal						\$90,000.00		
L-LINTHICUM

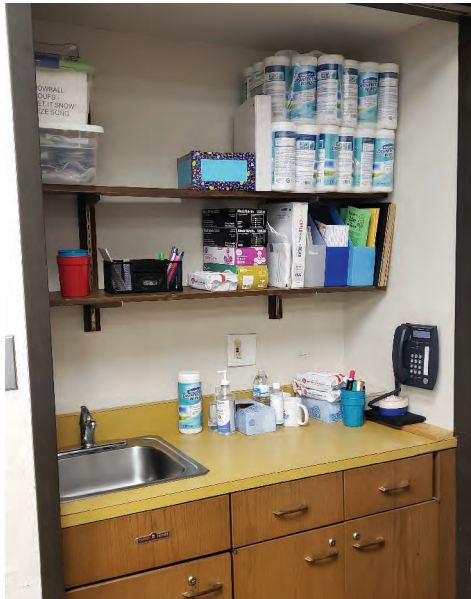
6.1		Millwork								
	L02	Kitchenette is not accessible and is under-utilized. Consider removal and replacement with storage closet.	L02 (4)				\$5,800.00			
	L13	Information Desk is not required for staffing, consider removal.				see above				
	L20	Staff work stations are dated and inefficient				X				Background overview commentary
	L21	Additional kitchenette countertop is inconsistent in appearance and lacks storage and functionality.	L21 (2)				\$3,500.00

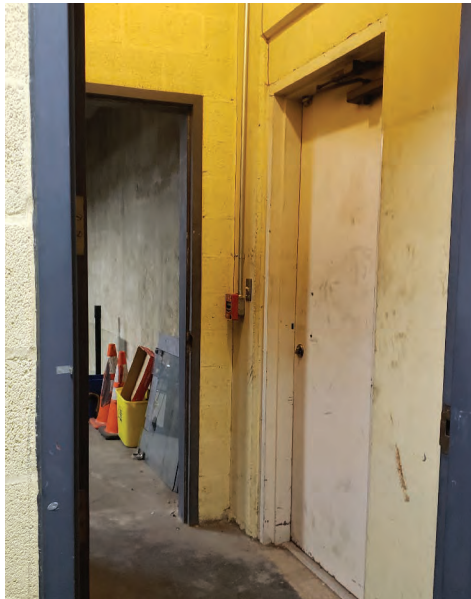
8.2		Door hardware								
	L02.1	Replace non compliant hardware				\$600.00				
	L02.2	Replace non compliant hardware				\$600.00				
	L03	Replace non compliant hardware				\$600.00				
	L06	Replace non compliant hardware				\$600.00				
	L22	Replace non compliant hardware				\$600.00				
	L24	Replace non compliant hardware				\$600.00				
	L27	Hardware does not allow egress to exterior	L27 (3) L27 (4)			\$4,200.00

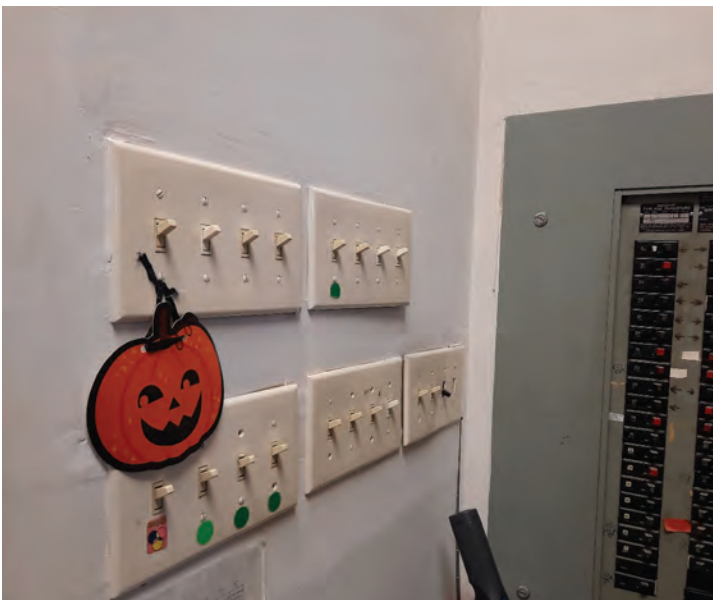
26.3		Wiring Devices								
	L21	Provide GFCI receptacle above pantry countertop.	L21 (E1)	1	\$400.00	\$400.00				
26.4		Lighting								
	Gen.	Existing interior lighting is predominantly fluorescent troffers, replace with energy efficient LED throughout. Ensure that new fixtures include air function capability where necessary.	L-GEN(E1) L-GEN(E2) L05 (E1)	1	LS		\$66,000.00			
	Gen.	No automatic lighting controls in building. Staff at this branch has requested that manual controls be maintained.								Background overview commentary
	LEXT	Exterior downlights mounted in soffits have been retrofit with LED lamps; however, the open reflector attracts wildlife and should be replaced with a lensed fixture. Replace all other existing exterior lights with new LED type.	L-EXT (E1) L-EXT (E2)	24	\$550.00		\$13,200.00			
	L02	Staff requested that dimmer switches be added.		3	\$400.00		\$1,200.00			
	L20	Permanently label light switches at switchbank.	L20 (E1) L20 (E2)	20	\$75.00		\$1,500.00

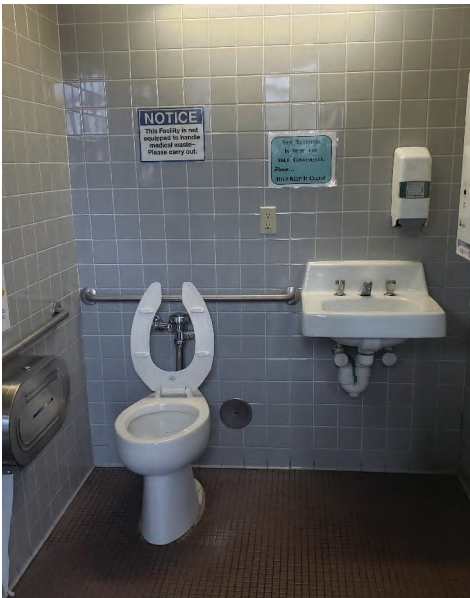
Item Ref.	Room	Description	Photo	Quantity	Unit Price	Priority 1	Priority 2	Priority 3	Priority 4	Comments
M-MARYLAND CITY										
1.0		General								
1.1		Accessibility								
	M03	Vertical grab bar not provided, full height mirror is compliant, fixture clearance overlap may be COMAR compliant but not ADAAG and ANSI A117.1 compliant. Relocate lavatory and swing door out	M03 (1) M03 (2)			\$5,500.00				
	M04	Vertical grab bar not provided, full height mirror is compliant, fixture clearance overlap may be COMAR compliant but not ADAAG and ANSI A117.1 compliant. Relocate lavatory and swing door out	M04 (1) M04 (2)			\$5,500.00				
	M07	Kitchenette counter height is 34", no knee space provided. Parallel approach may be impacted by accordion door's open position	M07 (1)			\$4,800.00				
	M08	Corridor slope appears to be less than 5% max slope for a sloped walkway (30" rise over 60'-0" run). Handrail not required by code, but requested by patrons. (3 rails)	M08 (1)			\$22,200.00

8.0		Openings								
8.1		Doors (interior)								
	M03	Re-swing or replace door with ADA renovations				\$2,500.00				
	M04	Re-swing or replace door with ADA renovations				\$2,500.00				
	M21	Replace door with ADA renovations				\$2,500.00

8.2		Door hardware								
	M03	Re-swing or replace hardware with ADA				\$600.00				
	M04	Re-swing or replace hardware with ADA				\$600.00				
	M21	Replace door hardware with ADA renovations				\$600.00				
M-MARYLAND CITY

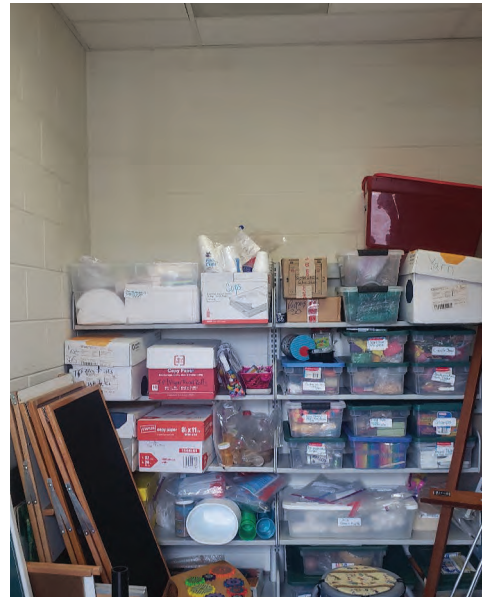
9.0		Finishes								
9.1		General								
	M06	Investigate water intrusion and staining observed on interior and exterior of wall	M06 (1)			X				FMD to address this exterior envelope condition
	M11	Bare CMU walls reflect sound, consider acoustical panels, hanging baffles, or clouds.	M11 (1)				\$55,000.00			
	M13	Bare CMU walls reflect sound, consider acoustical panels, hanging baffles, or clouds.	M13 (1)							
	M14	Bare CMU walls reflect sound, consider acoustical panels, hanging baffles, or clouds.	M14 (1)				\$3,500.00			
	M15	Bare CMU walls reflect sound, consider acoustical panels, hanging baffles, or clouds.	M15 (1)				\$30,000.00			
	M16	Bare CMU walls reflect sound, consider acoustical panels, hanging baffles, or clouds.	M16 (1)				SEE ABOVE

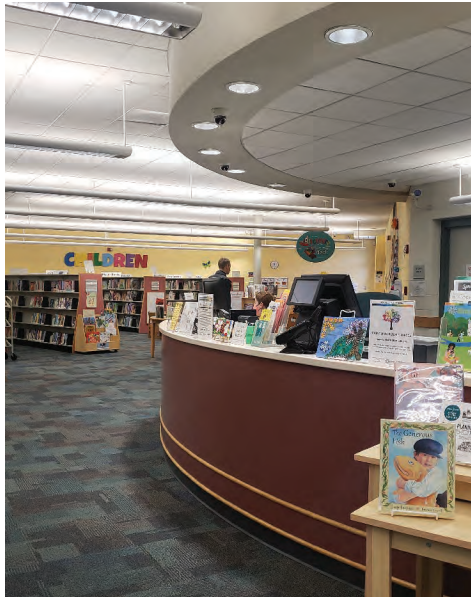
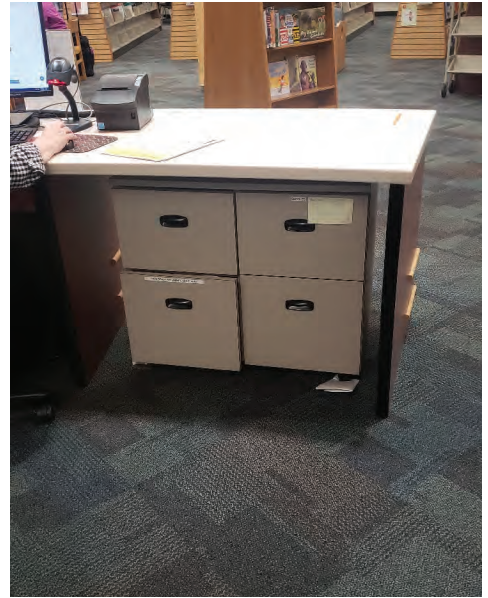
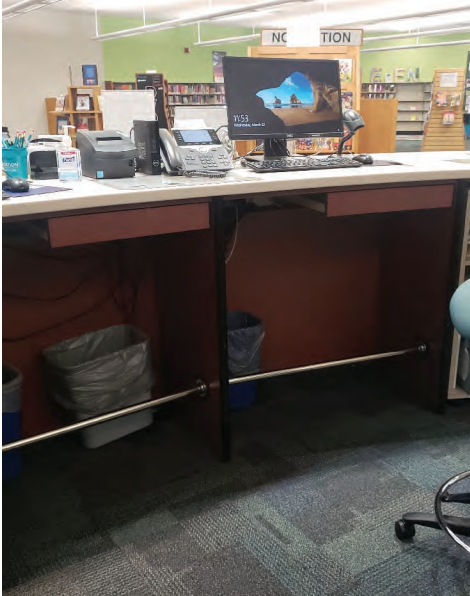
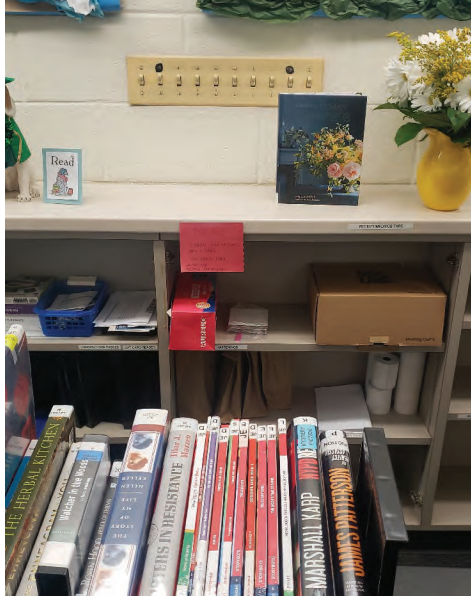
6.0		Wood								
6.1		Millwork								
	M10	Circulation desk's circular shape has wasted floor space	M10 (1) M10 (2) M10 (3) M10 (4)						X	SEE 1.5.3 ABOVE
	M20	Cubicles are oversized and inefficient, remove and replace with furniture	M20 (1) M20 (2)						\$20,000.00	Demolition of existing workroom cubicles only & electrical power. New FF&E Systems Furniture & IT Cabling by others.
M-MARYLAND CITY
