**ANNE ARUNDEL COUNTY
PUBLIC LIBRARY**

Library Facilities Assessment

August, 2023

Project L542406
WGM #202301.1

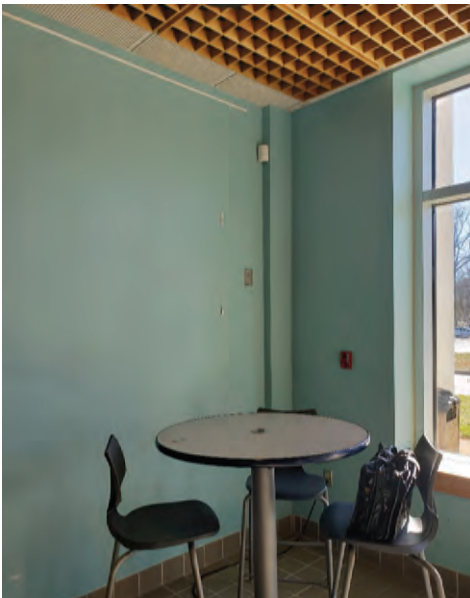
OD01 (1)

9.0		Finishes								
9.3		Tile								
	OD01	Quarry tile floors are damaged adjacent to OD03 & OD05 entries.	OD01 (2)			\$1,500.00				
	OD03	Tile floors and walls are serviceable, but dated in appearance.							\$16,000.00	
	OD04	Quarry tile floors are damaged adjacent to exit.	OD04 (2)			\$750.00				
	OD05	Tile floors and walls are serviceable, but dated in appearance.							\$1,650.00	
	OD31	Tile floors and walls are serviceable, but not functionally required for this room's current use.							\$6,550.00	
	OD54	Tile floors and walls are serviceable, but dated in appearance.							\$14,600.00	
	OD55	Tile floors and walls are serviceable, but dated in appearance.							\$14,600.00

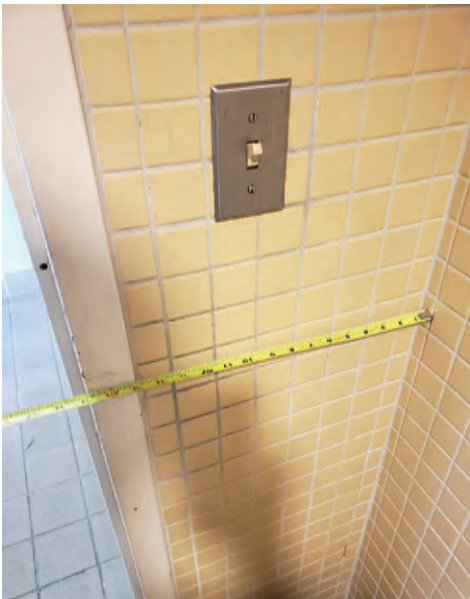
Item Ref.	Room	Description	Photo	Quantity	Unit Price	Priority 1	Priority 2	Priority 3	Priority 4	Comments
OD-ODENTON										
1.0		General								
1.1		Accessibility								
	OD03	Entry door clearance less than 18"	OD03 (1)			\$2,500.00				
	OD03	Stall lacks vertical grab bar	OD03 (2)			\$200.00				
	OD03	No urinal screen provided	OD03 (3)				\$800.00			
	OD05	Entry door clearance less than 18"	OD05 (1)			\$2,500.00				
	OD05	Stall lacks vertical grab bar				\$200.00				
	OD05	Floor drain slope is greater than 2%	OD05 (2)			\$1,500.00				
	OD06	Millwork at 36"	OD06 (2)			X				
	OD06	No fixture clearance at sink	OD06 (1)			X				
	OD24	Sink and counter accessibility	OD24 (1)			X				
	OD25	Toilet lacks vertical grab bar	OD25 (1)			\$200.00				
	OD26	Toilet lacks vertical grab bar	OD26 (1)			\$200.00				
	OD54	Stall lacks vertical grab bar	OD54 (1)			\$200.00				
	OD54	Floor drain slope is greater than 2%				\$1,500.00

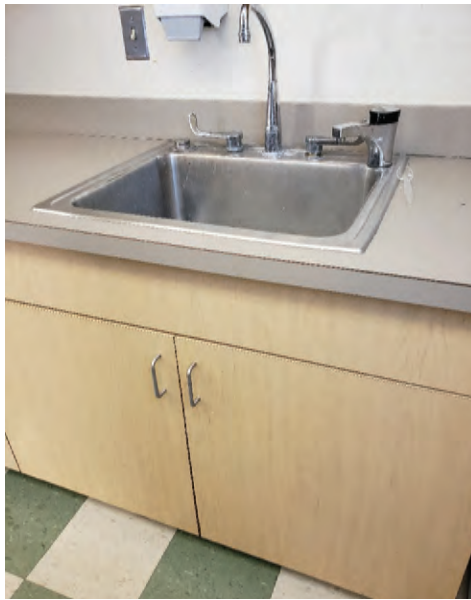
OD06 (1)

6.0		Wood								
6.1		Millwork								
	OD06	Consider removal of unused sink and millwork.							\$2,000.00	
	OD11	Consider removal and replacement of existing millwork with centrally-located moveable desks							X	SEE 1.5.1 ABOVE
	OD12	Consider removal and replacement of existing millwork with centrally-located moveable desks							X	SEE 1.5.1 ABOVE
	OD13	Consider removal and replacement of existing millwork and integration into dedicated business space							X	SEE 1.5.1 ABOVE
	OD21	Consider removal of existing cubicles and replacement with furniture system							X	SEE 1.2.7 ABOVE
	OD22	Consider removal of existing cubicles and replacement with furniture system							X	SEE 1.2.8 ABOVE
	OD51	Consider removal and replacement of existing millwork with smaller, possibly moveable desks							\$14,000.00	Demolition of existing information desks only; new carpet tiles & electrical power. New FF&E Systems Furniture & IT cabling by others.

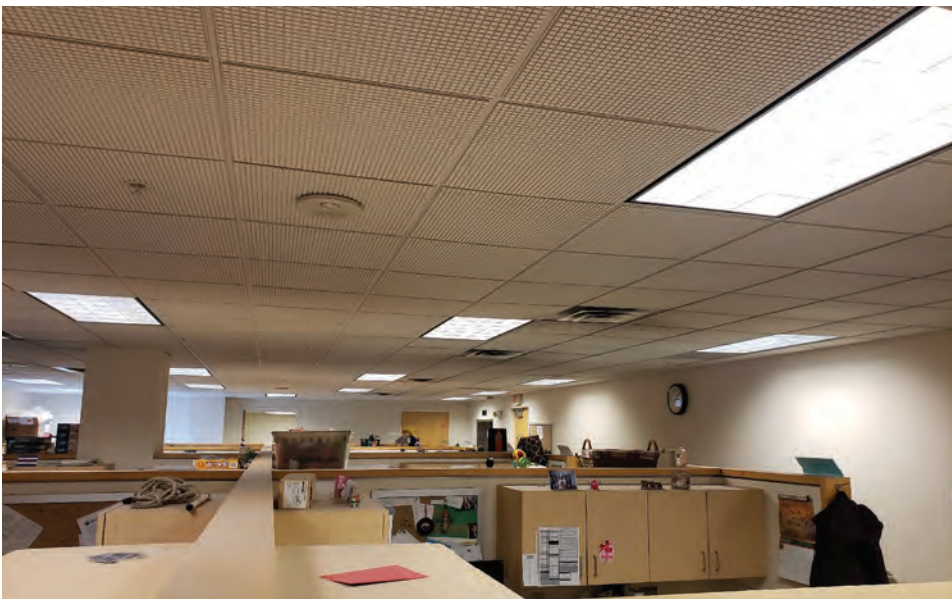
OD21 (1)

9.4		Ceilings								
	OD21	Some specialty 2x2 ceiling tiles have been removed and replaced with standard tiles. This was described as a way to preserve attic stock. Recommend the strategic replenishment of attic stock through renovation of less-noticeable back-of-house spaces.	OD21 (3)						\$5,000.00	Allowance for purchase of replacement back of house 2x2 tiles to gain more attic stock of original design 2x2 lay in tile
	OD22									
	OD23	Consider replacing all ceiling tiles in this room to help replenish attic stock.	OD23 (1)						\$1,500.00	
	OD24	Some damaged ceiling tiles to be replaced.	OD 24 (1)			\$400.00				
	OD27	Consider replacing all ceiling tiles in this room to help replenish attic stock.	OD27 (1)						\$2,550.00

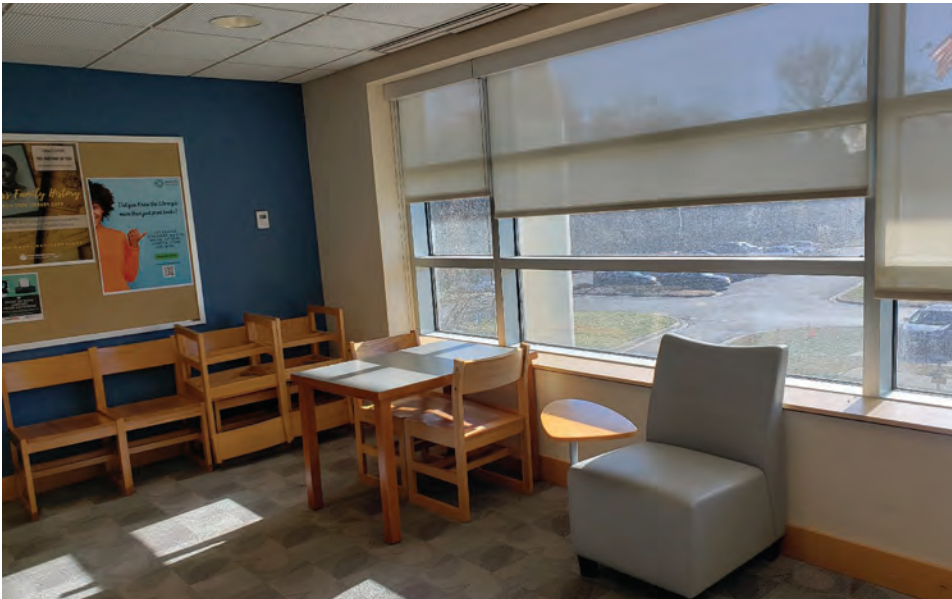
OD52 (1)

8.2		Door hardware								
	OD19	Replace hardware to provide occupancy indicator				\$500.00				
8.5		Window treatments								
	OD52	Window blinds are manually operated and ineffective at low sun angles. Overhangs are likely effective at high sun angles. Consider tinting windows to reduce glare						SEE ABOVE		
OD-ODENTON

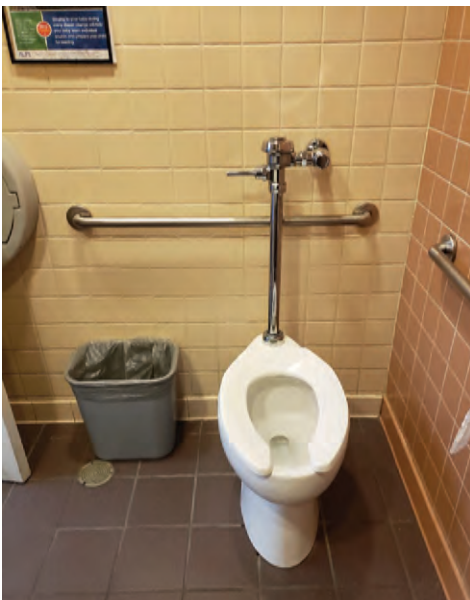
S04 (1)

8.0		Openings								
8.1		Doors (interior)								
	S04	Clearance, hardware				see above				
	S05	Clearance, hardware				see above				
	S06	Door may be replaced in future restroom renovation depending on proposed layout							X	Background overview commentary
	S21	Hardware								
	S22	Door location hinders access to restroom, recommend to replace door to the wall between S23 and S22	S22 (2)			\$3,500.00				
	S24	Solid door should be replaced with half glass at current work room/office use	S24 (1)				\$2,000.00

9.3		Tile								
	S04	Existing tile is dated but not damaged, replacement required for future renovation							\$5,100.00	
	S05	Existing tile is dated but not damaged, replacement required for future renovation							\$5,200.00	
	S23	Existing tile is dated but not damaged, replacement required for future renovation							\$3,450.00

8.2		Door hardware				\$600.00				
	S04	Replace hardware to match new				\$600.00				
	S05	Replace hardware to match new				\$600.00				
	S06	Replace hardware to match new				\$600.00				
	S21	Replace hardware to match new				\$600.00				
	S22	Replace hardware to match new				\$600.00				
	S23	Replace hardware to match new				\$600.00				
	S26	Replace hardware to match new	S26 (2)			\$600.00

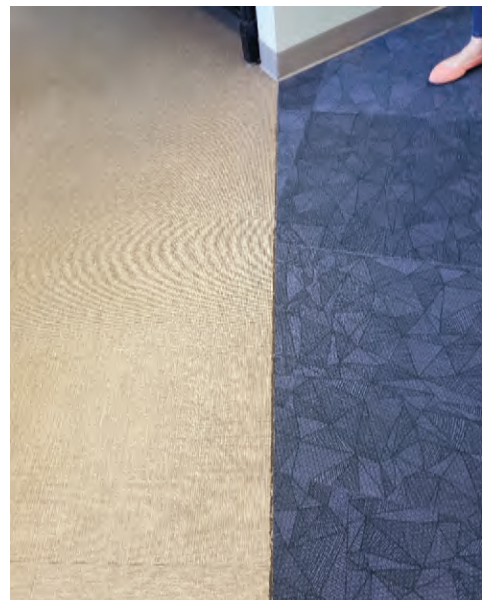
9.5		Flooring								
	S07	Missing transition at entry	S07 (1)			\$200.00				
	S21	Existing carpet is worn and in need of replacement						\$6,850.00		
	S22	Existing carpet is worn and in need of replacement, provide washable/vinyl surface at kitchenette						\$2,850.00		
	S24	Existing carpet is worn and in need of replacement						\$500.00		
	S25	Existing carpet is worn and in need of replacement	S25 (1)					\$1,050.00

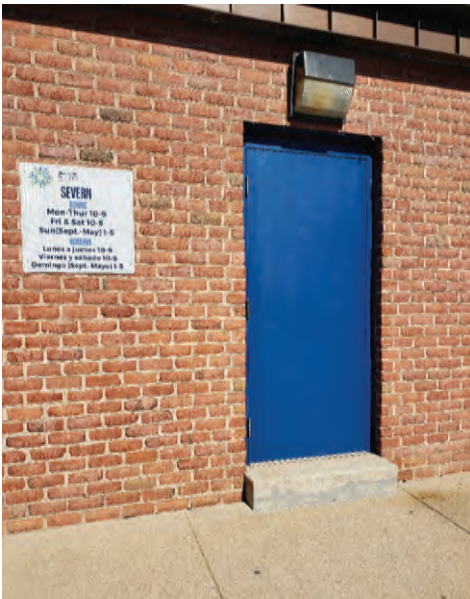
S09 (1)

5.0		Metals								
S-SEVERN										
6.0		Wood								
6.1		Millwork								
	S08	In like-new condition								Background overview commentary
	S09	In like-new condition								Background overview commentary
	S22	Kitchenette in poor condition				see above				
	S21	Built-in desks and cabinets are outdated and not deep enough for computer use						X		Background overview commentary
S-SEVERN

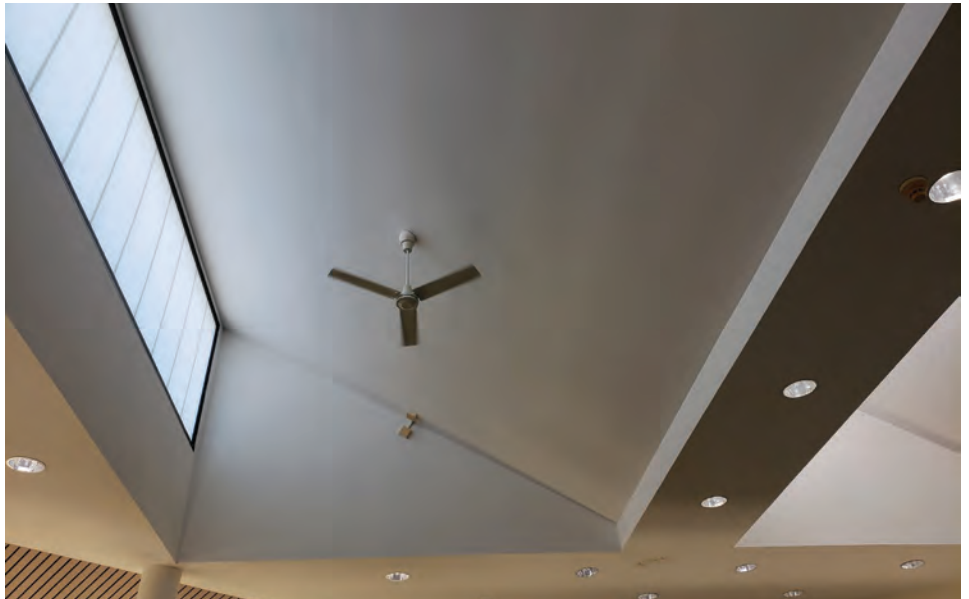
Item Ref.	Room	Description	Photo	Quantity	Unit Price	Priority 1	Priority 2	Priority 3	Priority 4	Comments
S-SEVERN										
9.0		Finishes								
9.2		GWB & partitions								
	S11	Patch and Paint drywall at water damage around sky-light	S11 (1)			\$1,500.00

9.6		Paint								
	S11	Patch and Paint drywall at water damage around sky-light	S11 (1)				\$2,000.00			
S-SEVERN										
10.0		Specialties								
10.1		Signage								
	S04	Confirm ADA signage				\$75.00				
	S05	Confirm ADA signage				\$75.00

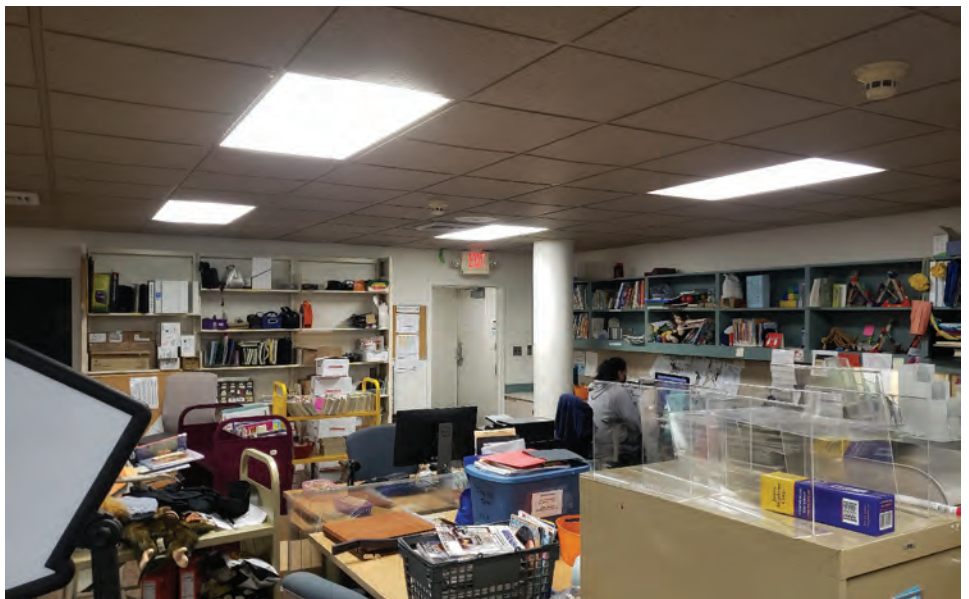
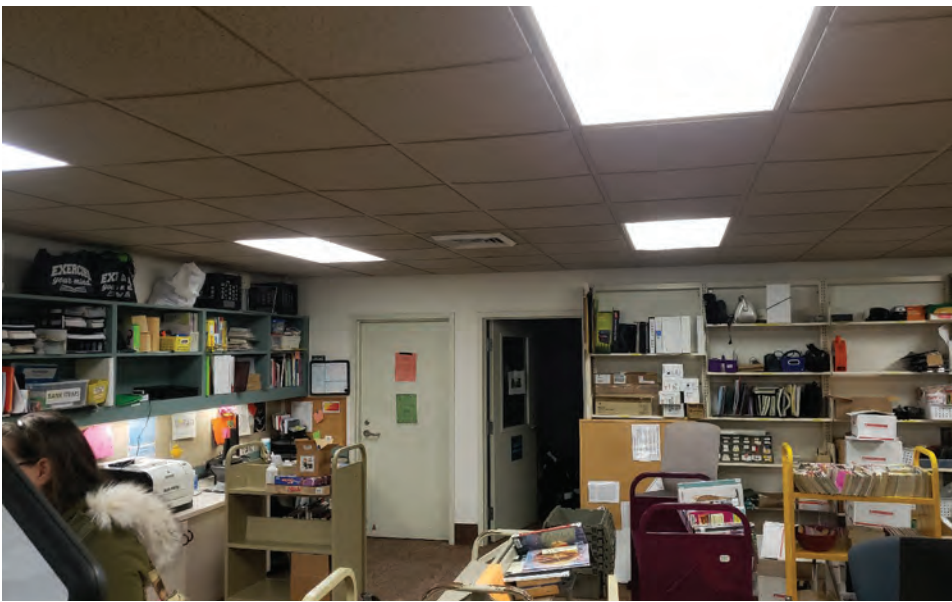
S21 (1)

9.4		Ceilings								
	S21	Existing grey ACT ceiling panels and grid, replace tiles and paint grid				\$6,850.00				
	S22	Existing grey ACT ceiling panels and grid, replace tiles and paint grid				\$2,900.00				
	S24	Existing grey ACT ceiling panels and grid, replace tiles and paint grid				\$500.00				
	S25	Existing grey ACT ceiling panels and grid, replace tiles and paint grid				\$1,050.00

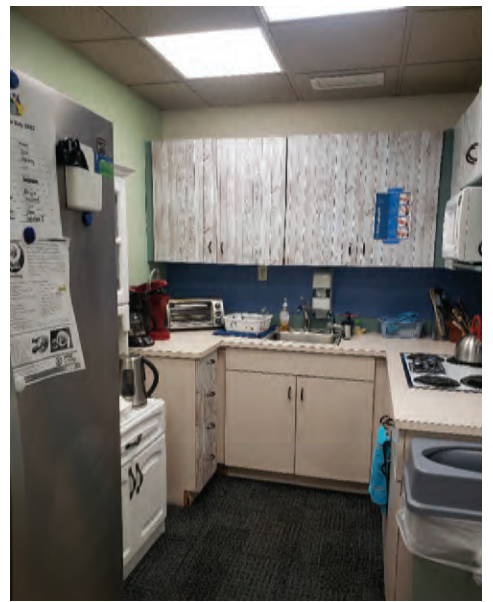
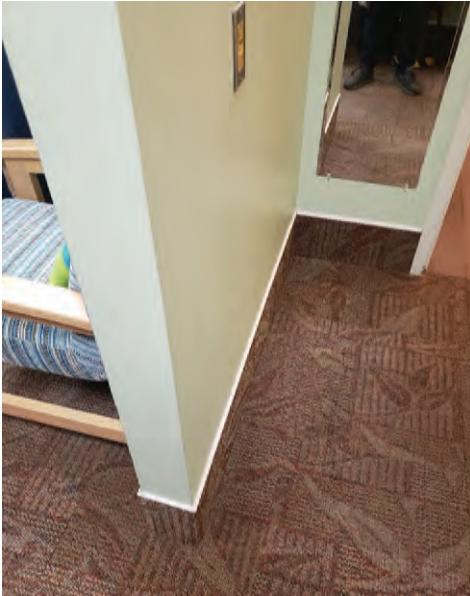
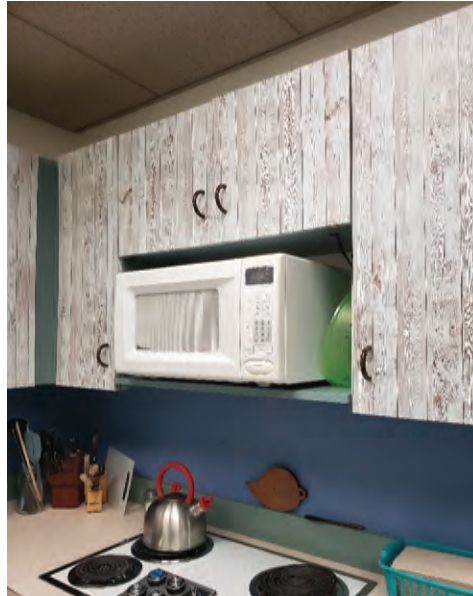
S22 (1)

28.1		Fire Alarm								
28.1.1		General - fire alarm system completely replaced in 2008, with the exception of some smoke detectors.								Background overview commentary
	S22	Fire alarm horn/strobe mounted above door at far end of room, and does not appear to provide complete room coverage. Relocate device.		1	\$400.00	\$400.00				
PRIORITY TOTALS						\$82,913.00	\$52,300.00	\$11,700.00	\$159,550.00

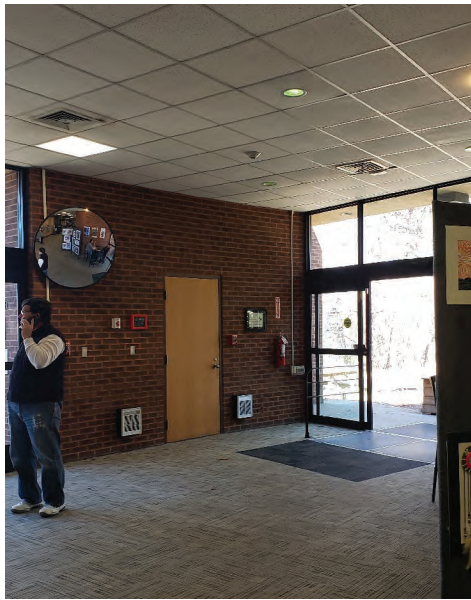
1.1.2	SP02	Non-lever door hardware	SP02 (1)			\$600.00				
1.1.3	SP03	Entry door is not accessible from pull side. Mirrors are more than 40" AFF. Install auto door openers and replace mirrors	SP03 (1)			\$12,500.00

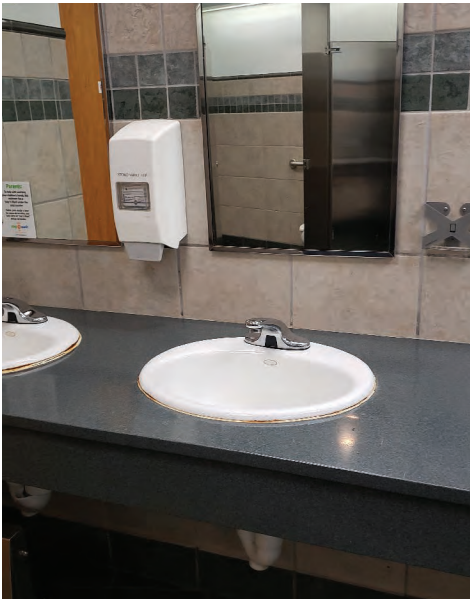
1.1.4	SP04	Entry door is not accessible from pull side. Mirrors are more than 40" AFF. Install auto door openers and replace mirrors	SP04 (1)			\$12,500.00

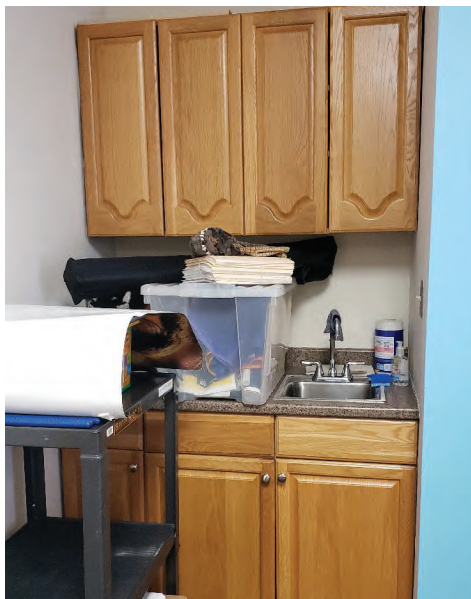
SP07 (1)

5.0		Metals								
SP-SEVERNA PARK										
6.0		Wood								
6.1		Millwork								
	SP07	Millwork not used, could be removed for better use as storage or conference expansion.						x		SEE 1.1.7 ABOVE
	SP10	Fixed circulation desk is not as useable as mobile desks at other branches.	SP10 (1) SP10 (2) SP10 (3)					\$11,000.00		Seek a FF&E solution to providing flexible circulation desk solution. Demolition of existing and new carpet tiles and electrical only. IT cabling by others
	SP13	Computer tables are inefficient use of space, at least one could be removed or both, and replaced with furniture.	SP13 (2) SP13 (3)					\$3,500.00		Seek a FF&E solution to providing flexible circulation desk solution. Demolition of existing and new carpet tiles and electrical only. IT cabling by others
SP-SEVERNA PARK

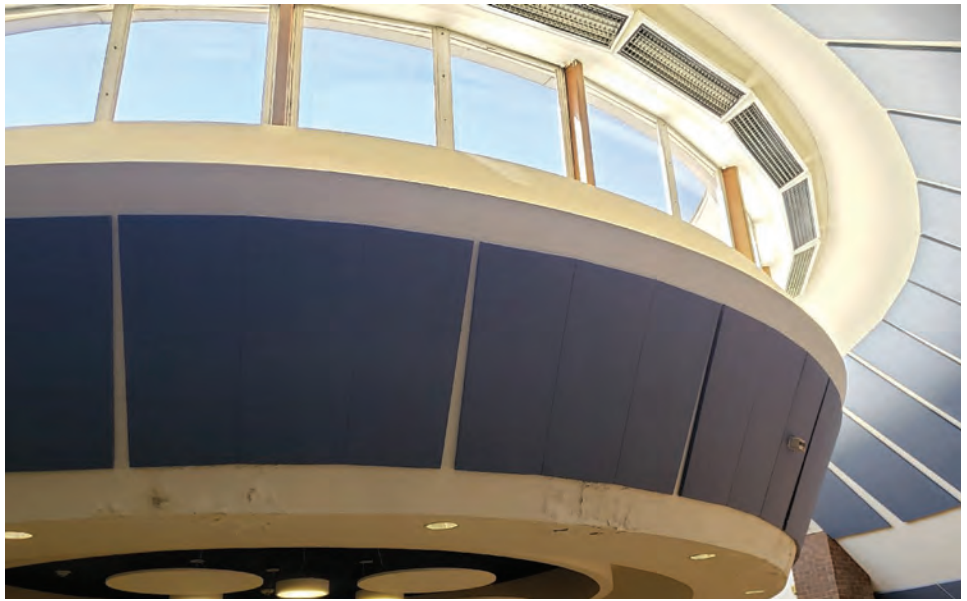
9.2		GWB & partitions								
	SP12	Center bulkhead is water-damaged, drywall to be repaired and repainted.	SP12 (1)			\$5,200.00				
	SP17	Perimeter bulkheads are damaged, repair and repaint	SP17 (1)			\$5,000.00				
	SP22	Repair water-damaged ceiling	SP22 (1)			\$300.00

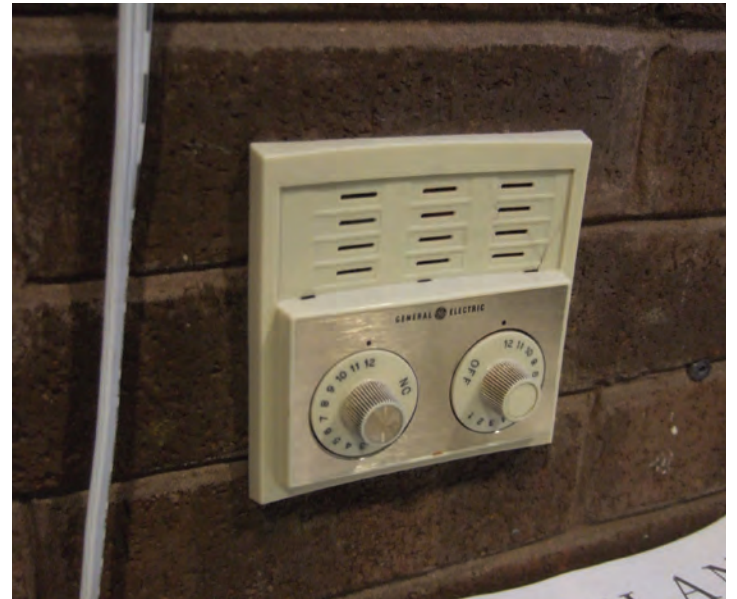
26.4		Lighting								
		Replace fluorescent lighting throughout with energy efficient LED.	SP11 (E3) SP11 (E6)	1	LS		\$135,000.00			
		No automatic lighting controls.								Background overview commentary
		Replace non-functioning exit signs with new LED type.	SP (E1)	2	\$450.00	\$900.00				
	EXT	Replace exterior wall mounted lights with energy efficient LED.	SP-EXT (E1) SP-EXT (E2)	9	\$550.00		\$4,950.00			
	SP01	Replace damaged light switch.	SP01 (E1)	1	\$125.00	\$125.00				
	SP08	Label light switches. Dimmer switches are not compatible with relamped downlights. Replace with new dimmers.	SP08 (E1)	1	LS		\$850.00			
	SP10	Existing rotary style lighting controllers operate the main library lights in several zones; however the controllers are not intuitive and have become difficult to operate. The lighting zones can be combined and simplified. Replace controllers with permanently labeled toggle switches controlling lighting contactors.	SP10 (E1)	1	LS		\$2,250.00

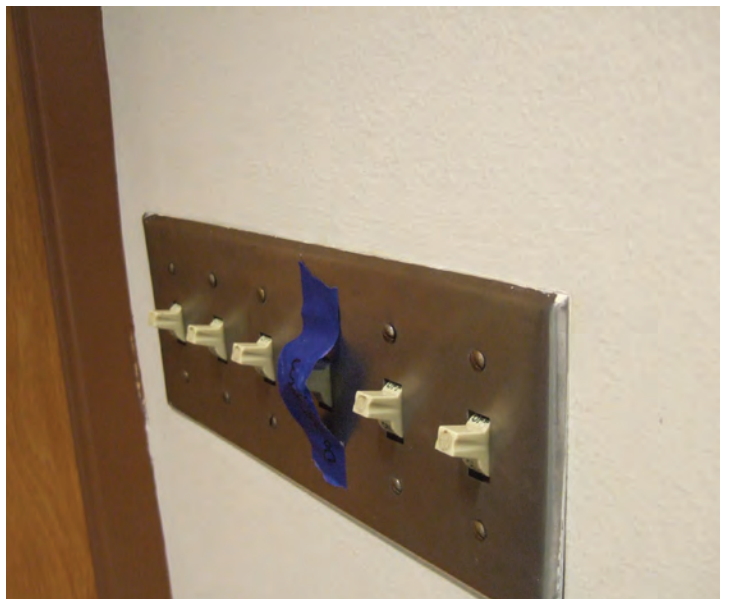
SP11	1' x 4' fluorescent lights surrounding central circular glass feature are difficult to relamp, and several are not operating. Illumination below this feature is poor. Replace with a different lighting scheme utilizing LED fixtures. Numerous 4' diameter florescent lights throughout main area are difficult to maintain; recommend replacement with readily available LED fixtures.	SP11 (E1) SP11 (E2) SP11 (E4) SP11 (E5) SP11 (E7)				X			Included in lighting retrofit cost given above.
	SP23	Permanently label light switches. Review non-functioning switch with owner and remove or repair as necessary.	SP23 (E1)	1	LS		\$600.00

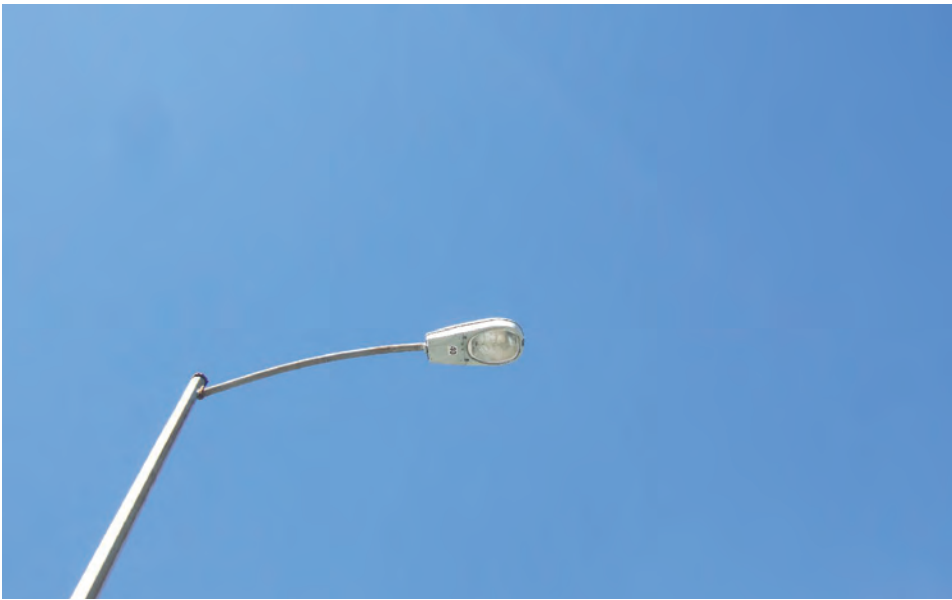
26.5		Site Lighting								
26.5.1		Relamp existing fixtures with LED lamps, or replace complete fixture with LED type.	SP-EXT (E3)	8	\$800.00		\$6,400.00			Cost is to replace complete fixtures.
SP-SEVERNA PARK

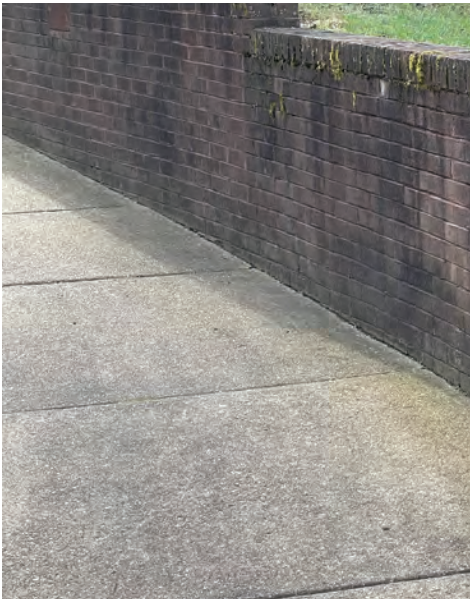
2.8.5		Brick wall along entry drive appears to be in good condition	SPS (2)							
2.8.6		Maintenance/Storage wooden shed is present onsite	SPS (11)							
SP-SEVERNA PARK
